Magnetec Monthly Chronicle

Issue No.10 " FROM THE FIELD " October 2005

Is it Stress Corrosion, Corrosion Fatigue, or Hydrogen Induced?

Subject: Cracking

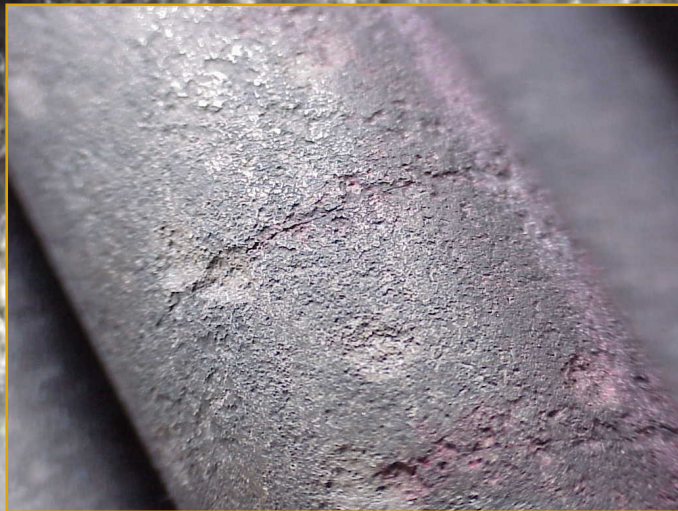
Note pitting attack along crack formation

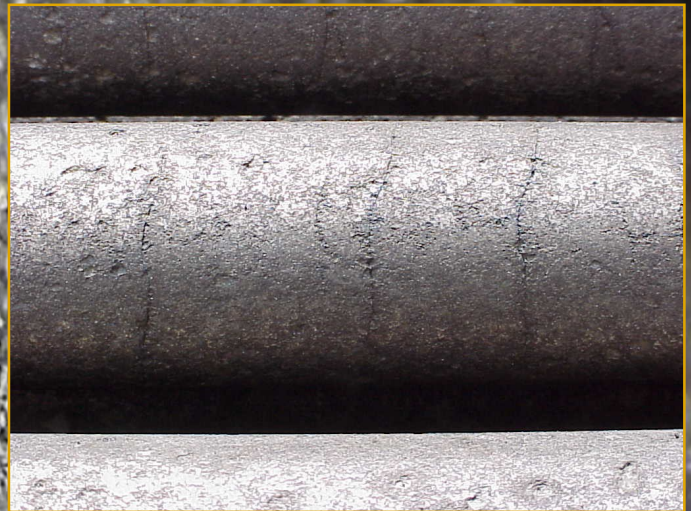
Numerous crack formations as seen along affected tube length portion

Based on the location of the cracks, crack pattern, concentration and depth, the cracking mechanism appeared to be related to a flow process across the bundle matrix which alludes to either a corrosion/chemical attack, or a heat related phenomena, or a combination of both. The cracks appeared to be consistent in their spacing and relative crack depths as the process flows passed through their specific bundles which is indicative of the driving event diminishing across the bundle length and therefore is believed to be related to temperature gradients. The process is in the mid range of the recommended operating temperatures for the 2205 material and well below the 600 degree operating limit specified by the manufacturer and the ASME (885 ferrite embrittlement). The post bending stress relieved U-bends were noted with no cracking type mechanism in either bun-

dle which tends to indicate a heat treatment condition (straight section) from the manufacturer that is susceptible to the cracking mechanism. The inter-relationship of corrosion fatigue, stress corrosion and hydrogen embrittlement cracking mechanisms, and the wide spectrum of conditions, both in material environment, and metallurgical states, generally overlap and can be a combination of any and/or all the phenomena. There tends to be a central initiating factor that encompasses all three of the individual mechanisms and crack initiation to ultimate failure might be classified to any of the separate mechanisms as the crack progress's through stages. It should be noted that the bundles in question might have experienced a single event or limited number event cycle that initiated the crack sequence, & crack propagation has since ceased. This condition could only be determined by metallographic tests of the material and crack face for telltale signs of re-passivation or continued crack growth. The bundles were detected with O.D. pitting with depths of 15%-35% along the tube length and across the entire bundle matrix, however, this mechanism was not considered a service related problem. Cracks most probably initiated at the pit locations. Based on the age of the bundle, defect depths, and economic loss's due to re-occurring failures, both bundles were retubed.

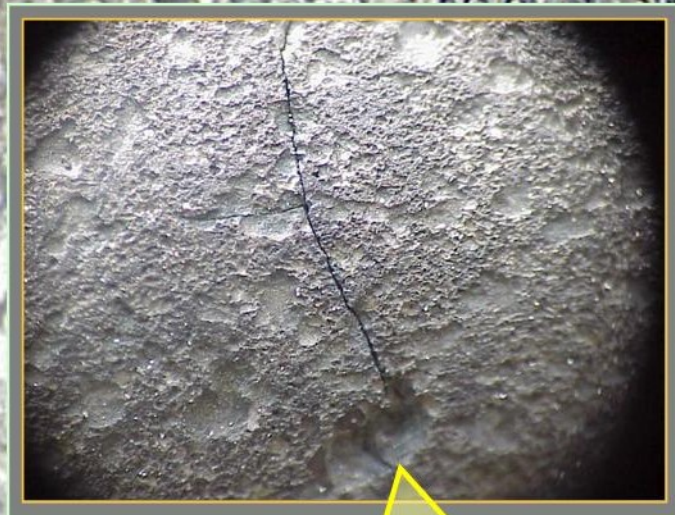
**Single crack pit
initiation site**

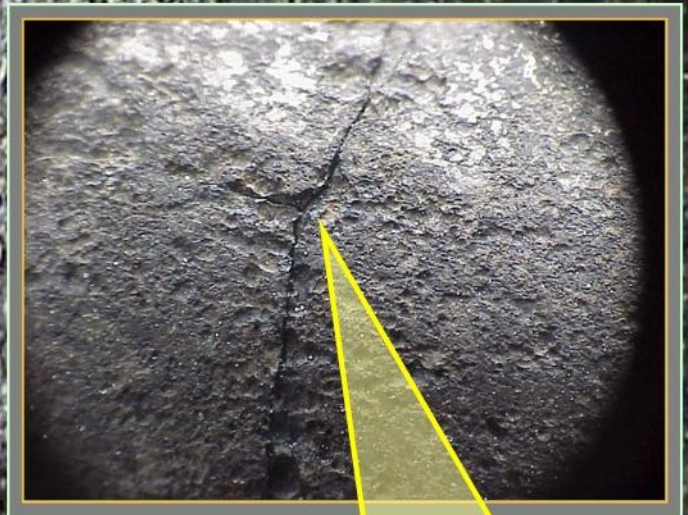
**Note axial crack propagation
from circ. crack**
