Magnetec Monthly Chronicle

Issue No.10 " FROM THE FIELD " October 2005

Is it Stress Corrosion, Corrosion Fatigue, or Hydrogen Induced?

Subject: Cracking

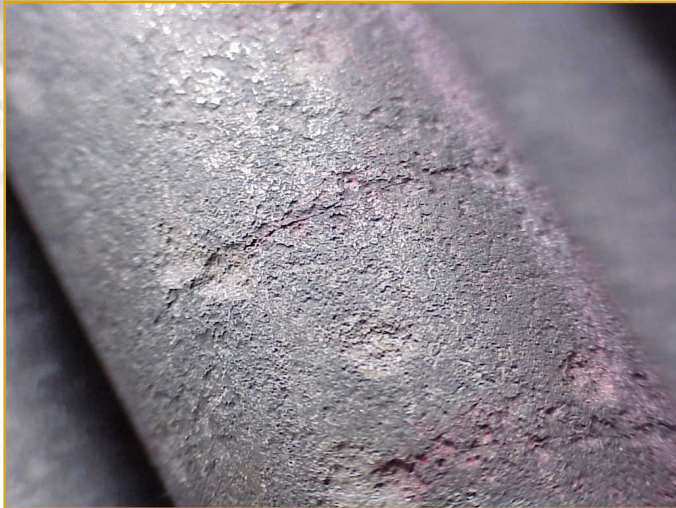
Note pitting attack along crack formation

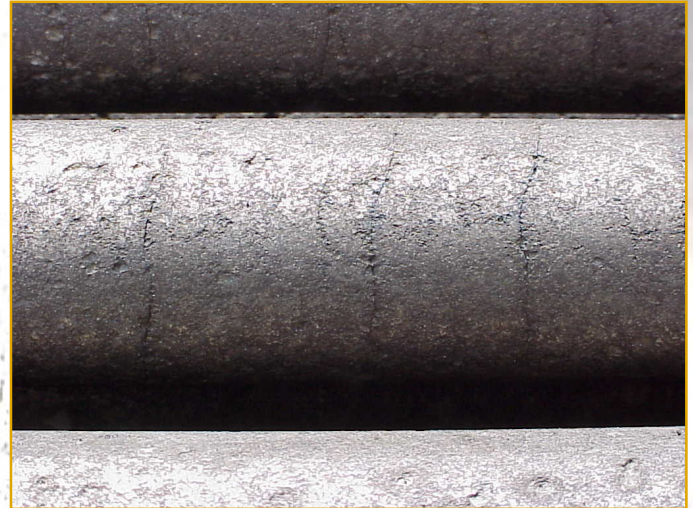
Numerous crack formations as seen along affected tube length portion

Based on the location of the cracks, crack pattern, concentration and depth, the cracking mechanism appeared to be related to a flow process across the bundle matrix which alludes to either a corrosion/chemical attack, or a heat related phenomena, or a combination of both. The cracks appeared to be consistent in their spacing and relative crack depths as the process flows passed through their specific bundles which is indicative of the driving event diminishing across the bundle length and therefore is believed to be related to temperature gradients. The process is in the mid range of the recommended operating temperatures for the 2205 material and well below the 600 degree operating limit specified by the manufacturer and the ASME (885 ferrite embrittlement). The post bending stress relieved U-bends were noted with no cracking type mechanism in either bundle which tends to indicate a heat

treatment condition (straight section) from the manufacturer that is susceptible to the cracking mechanism. The inter-relationship of corrosion fatigue, stress corrosion and hydrogen embrittlement cracking mechanisms, and the wide spectrum of conditions, both in material environment, and metallurgical states, generally overlap and can be a combination of any and/or all the phenomena. There tends to be a central initiating factor that encompasses all three of the individual mechanisms and crack initiation to ultimate failure might be classified to any of the separate mechanisms as the crack progress's through stages. It should be noted that the bundles in question might have experienced a single event or limited number event cycle that initiated the crack sequence, and crack propagation has since ceased. This condition could only be determined by metallographic tests of the material and crack face for telltale signs of re-passivation or continued crack growth. The bundles were detected with O.D. pitting with depths of 15%-35% along the tube length and across the entire bundle matrix, however, this mechanism was not considered a service related problem. Cracks most probably initiated at the pit locations. Based on the age of the bundle, defect depths, and economic loss's due to re-occurring failures, both bundles were retubed.

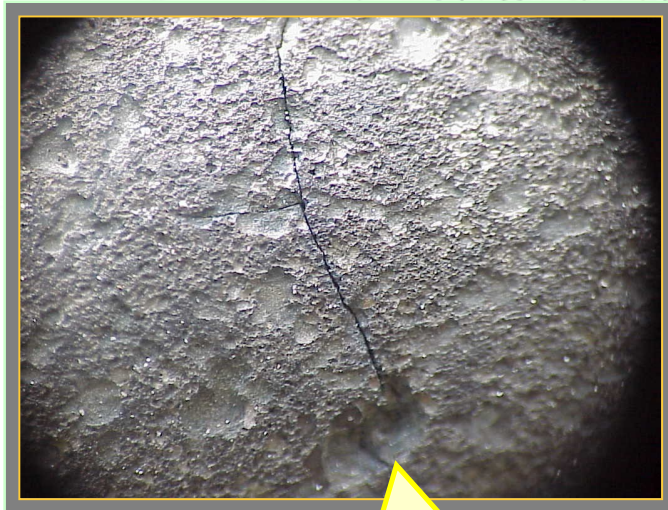
Single crack pit initiation site

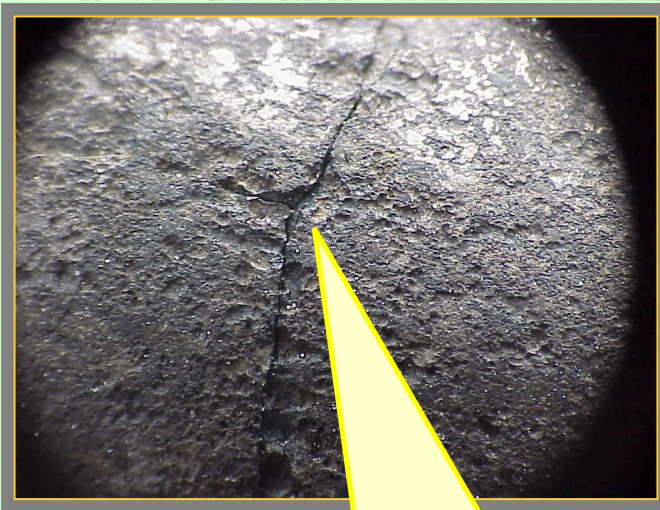
Note axial crack propagation from circ. crack
