Magnetec Monthly Chronicle

Issue No.11 " FROM THE FIELD " November 2005

Reported Failure Was Unexpected and not Confirmed Prior to Bundle Dismantle

Subject: The Erosive Power of Steam!

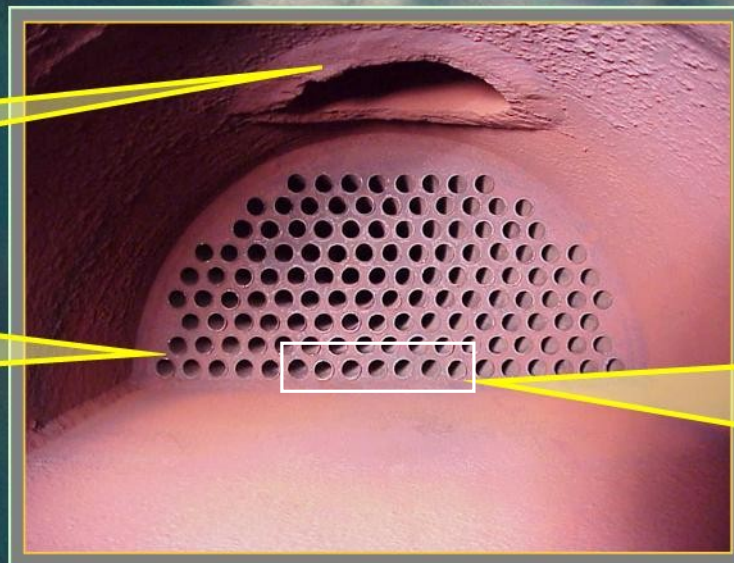
Inlet Steam Pass

Y's, Tee's, etc.) are in much higher concentration than straight flow runs. Erosion can occur with any process feed and is found in the highest concentration when the laminar flow is disrupted. Based on Eddy current and Video probe visual inspection, the failures noted were very large, and correct operation of the bundle could not be attained. The bundle, while seemingly insignificant in size and process, caused many problems in keeping the main steam supply at the correct limits and characteristics. Based on the inspection results there were 7 tubes plugged due to active failures and/or preventative plugging. With the severely eroded tubes removed from service, the bundle should provide many years of service and replacement could be held off. The tubes were plugged by the Magnetec using Pop-a-plug type plugs.

**Erosion Affected
Center Row**

**Tubes
with
Severe
Erosion &
Failures**

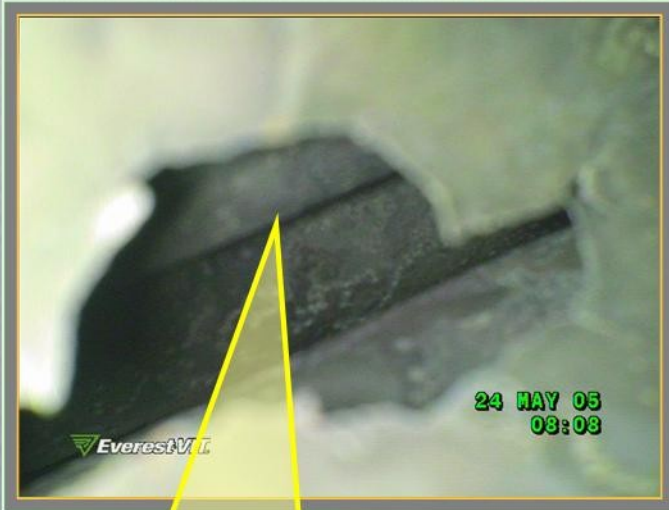
View Looking through Tube to Adjacent Tubing

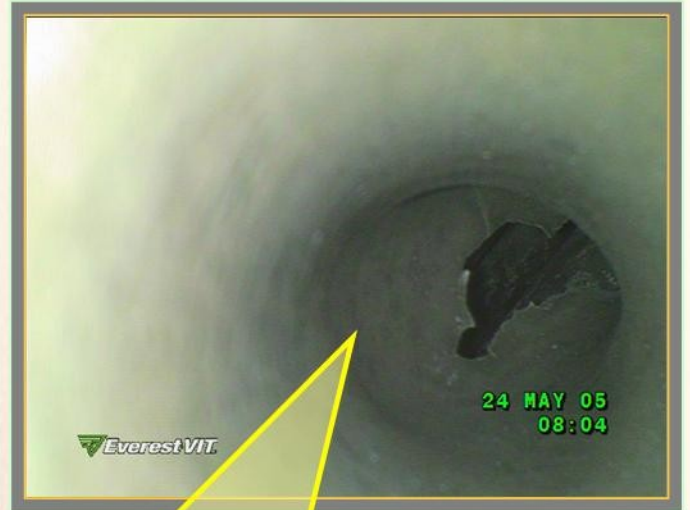
View from Straight Tube Section to U-bend
