Magnetec Monthly Chronicle

Issue No.11 " FROM THE FIELD " November 2005

Reported Failure Was Unexpected and not Confirmed Prior to Bundle Dismantle

Subject: The Erosive Power of Steam!

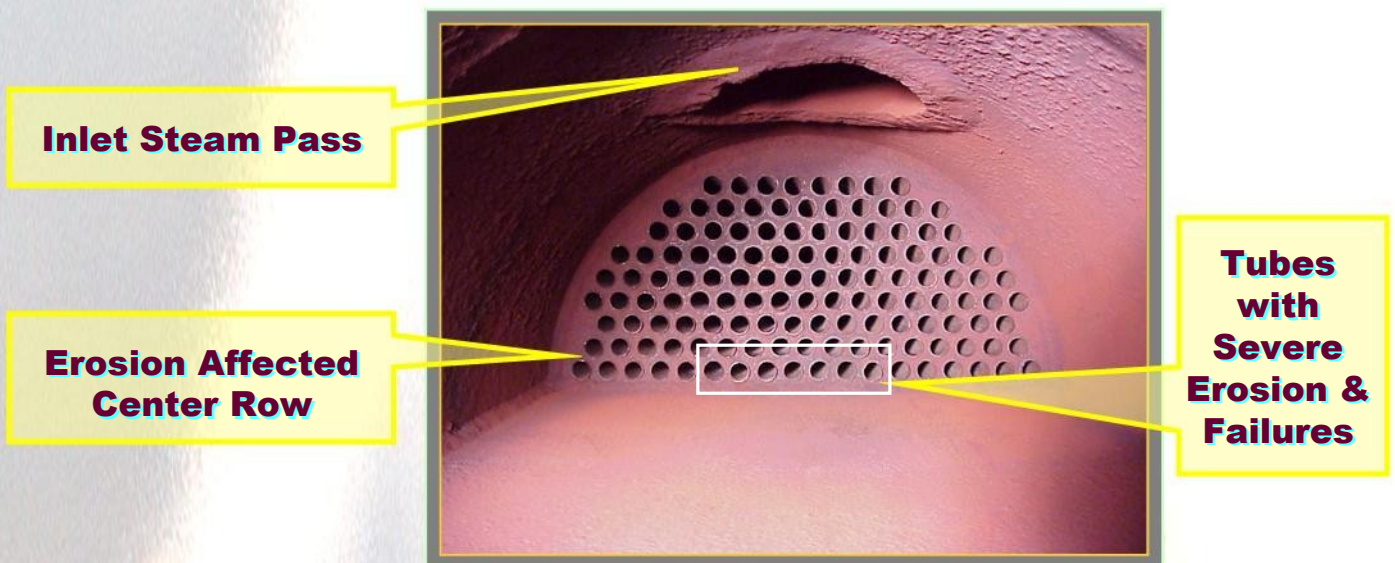
in much higher concentration than straight flow runs. Erosion can occur with any process feed and is found in the highest concentration when the laminar flow is disrupted. Based on Eddy current and Video probe visual inspection, the failures noted were very large, and correct operation of the bundle could not be attained. The bundle, while seemingly insignificant in size and process, caused many problems in keeping the main steam supply at the correct limits and characteristics. Based on the inspection results there were 7 tubes plugged due to active failures and/or preventative plugging. With the severely eroded tubes removed from service, the bundle should provide many years of service and replacement could be held off. The tubes were plugged by the Magnetec using Pop-a-plug type plugs.

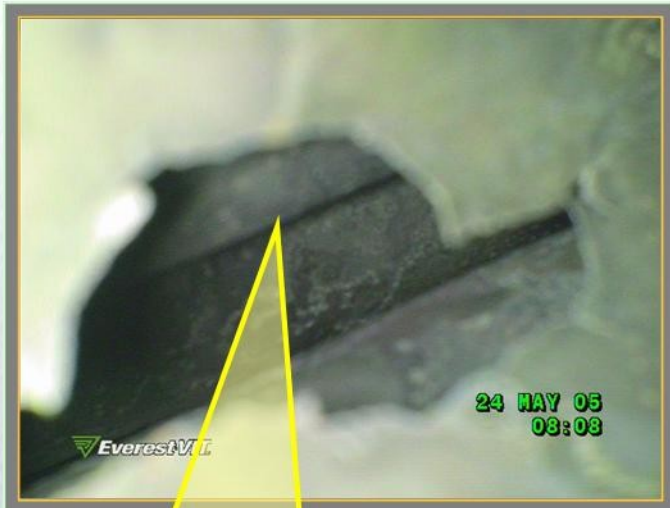
View Looking through Tube to Adjacent Tubing

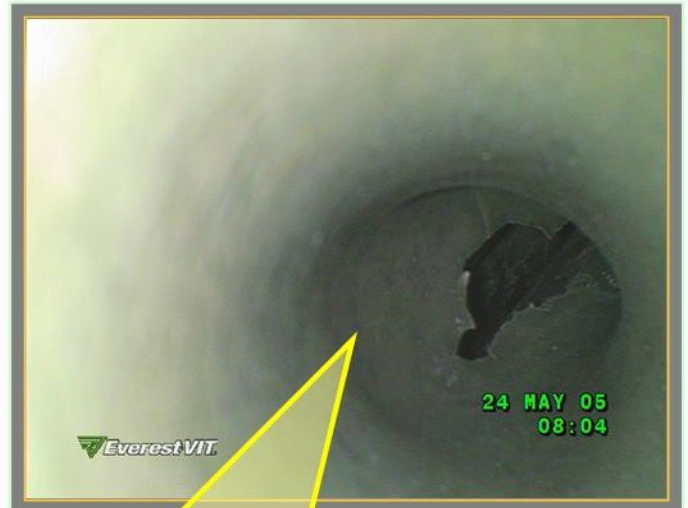
View from Straight Tube Section to U-bend
