Magnetec Monthly Chronicle

Issue No.12 " FROM THE FIELD " December 2005

Reactor Effluent Condensers

**Subject: Reactor Effluent Overhead Condensers
Ammonium Bisulfide Corrosion**

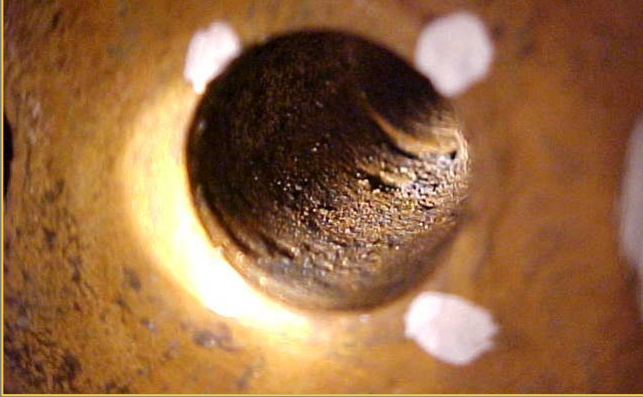
**Ammonia bisulfide corrosion/pitting
within roll area**

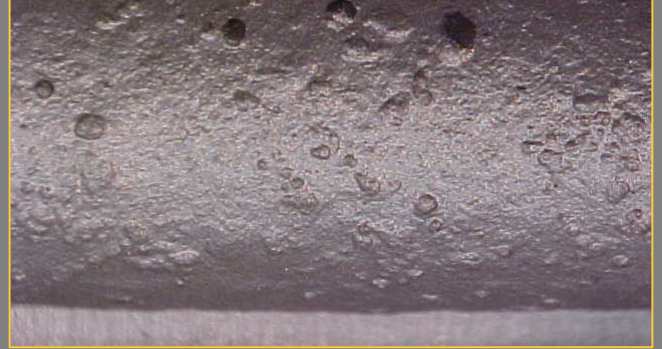
**Removed tube sample – Top Row –
Middle of tube**

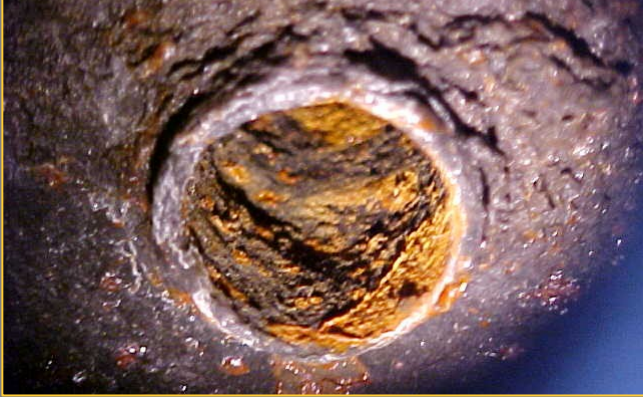
**Heavy fouling and tube end
corrosion**

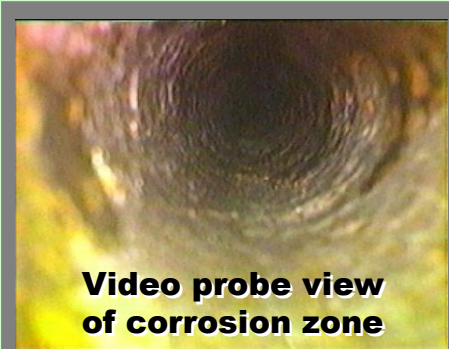
**Video probe view
of corrosion zone**
