# Magnetec Monthly Chronicle

Issue No.13 " FROM THE FIELD " March 2006

### Brass Crude Overhead Condenser

**Subject: Pitting in Brass Crude Overhead Condenser**

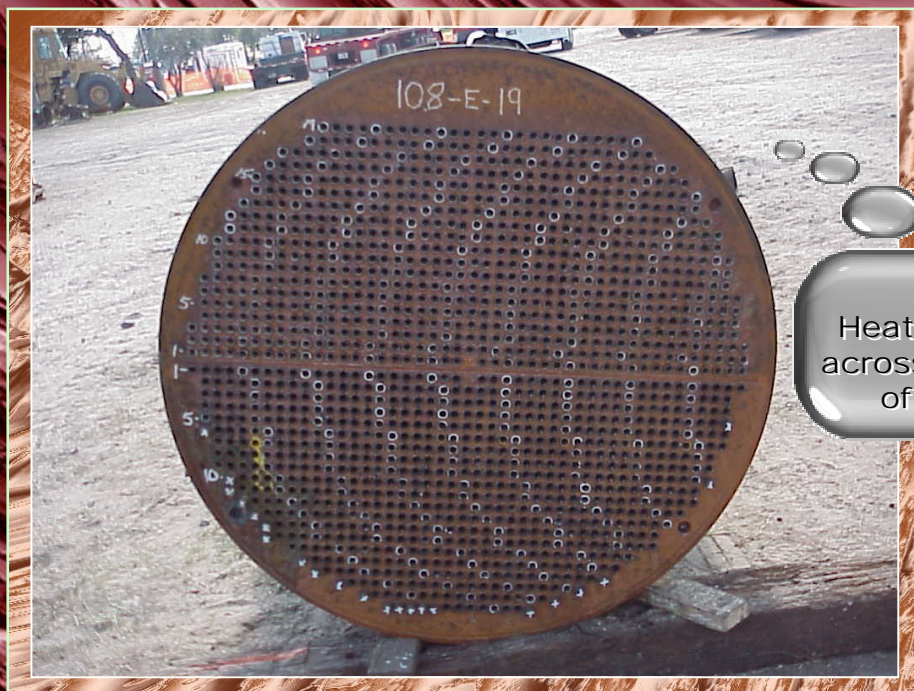
High  
Heat Gradient  
across Top Row  
of Tubes

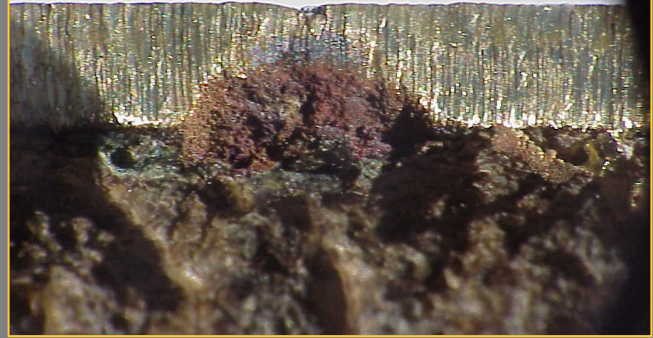
enters the bottom channel nozzle and makes two passes through the tubing. This condition makes the middle shell side inlet a high temperature area and would tend to layout cooling water deposits at a much higher rate than other parts of the bundle. The tubing consists of 1050 straight tubes – .750 O.D. X .065 min wall X SB-111-443 X 20 Foot long and are 12 years old. Upon visual inspection there were numerous holes noted near/adjacent to the deflection plate which corresponds to the high heat /fouling

Sample Tube Removed  
from top Row Adjacent to  
Middle Deflection Plate

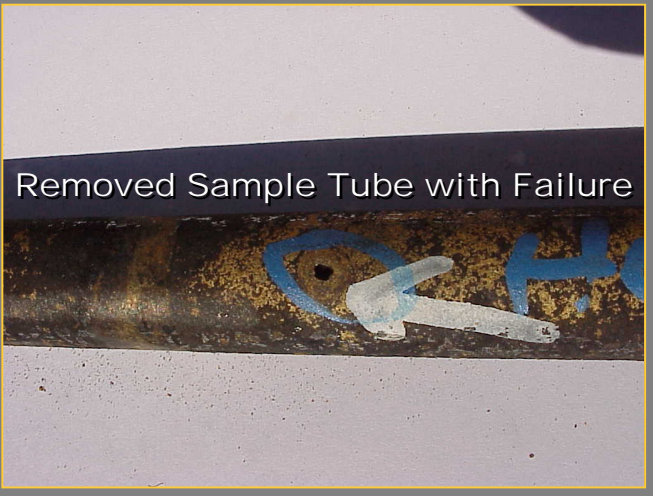
Removed Sample Tube with Failure

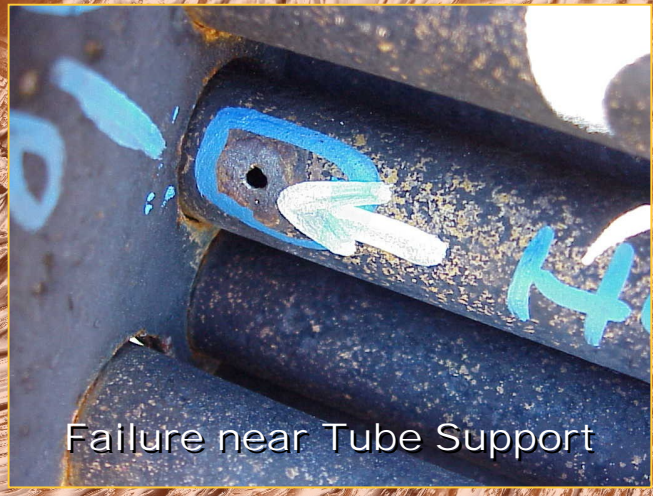
Failure near Tube Support

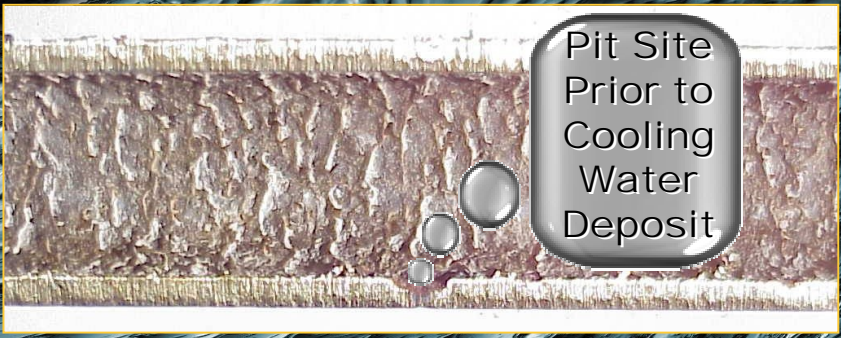
Pit Site  
Prior to  
Cooling  
Water  
Deposit
