# Magnetec Monthly Chronicle

Issue No.13 " FROM THE FIELD " March 2006

**Subject: Pitting in Brass Crude Overhead Condenser**

**Low Heat Levels for Long Periods of Time  
Have the Same Net Effect as  
High Heat Levels for Short Time Frames**

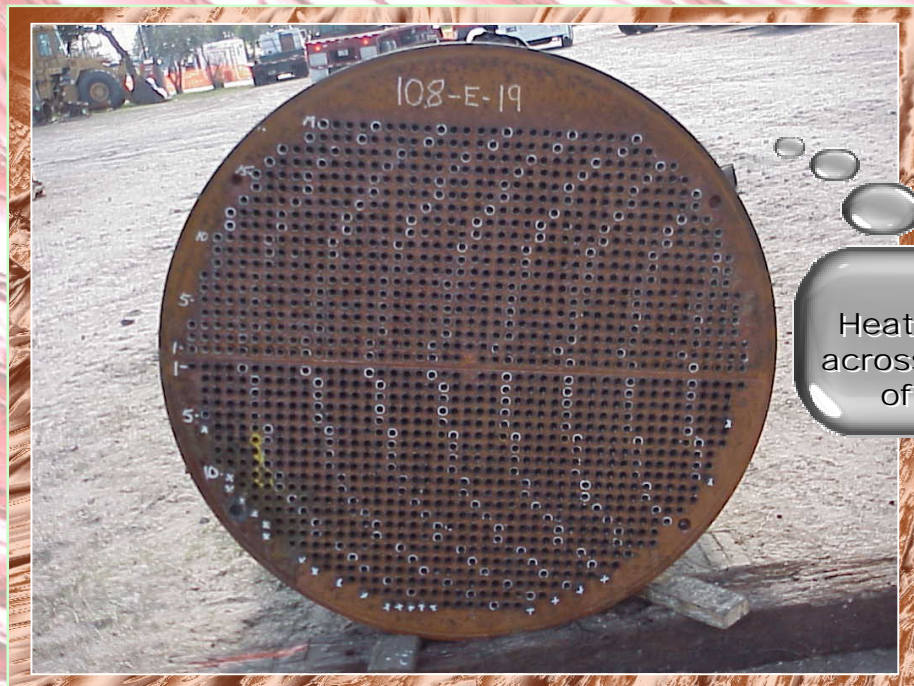
High  
Heat Gradient  
across Top Row  
of Tubes

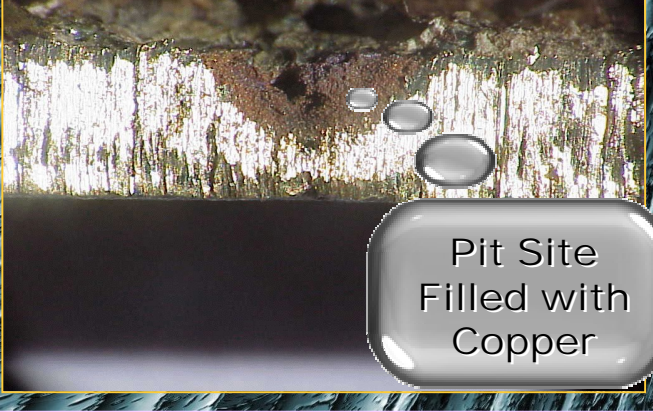
Copper Lay-out in Pit Site,  
Defect Depth 60%

Pit Site  
Filled with  
Copper

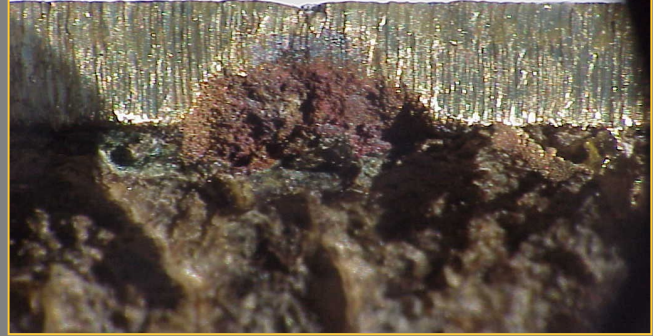
Sample Tube Removed  
from top Row Adjacent to  
Middle Deflection Plate

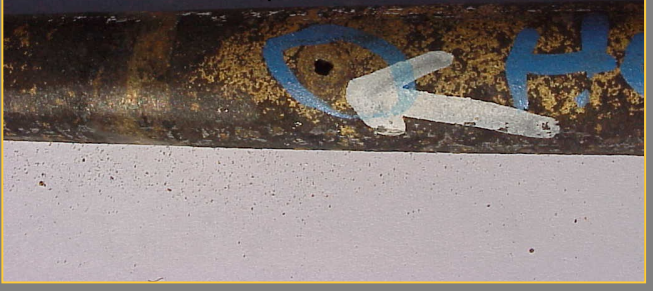
Removed Sample Tube with Failure

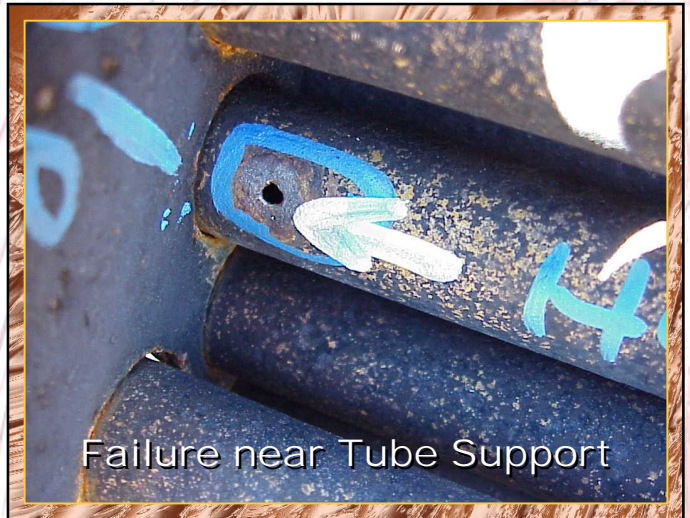
Failure near Tube Support

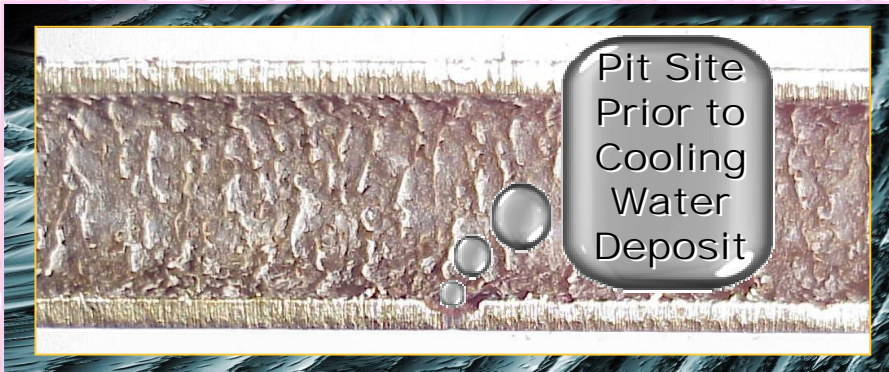
Pit Site  
Prior to  
Cooling  
Water  
Deposit
