Issue No.14

April 2006

Magnetec Inspection, Inc.

Subject: Localized Over Heat & Associated Failures in Stainless Steel Pipe

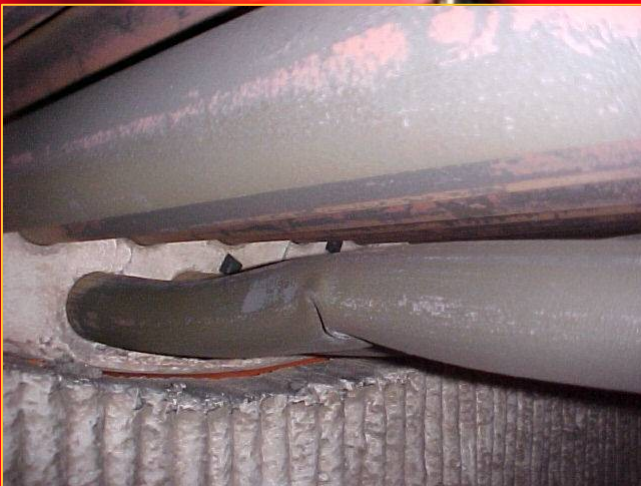
View of Pipe Directly Adjacent to Inlet Hot Combustion Gases

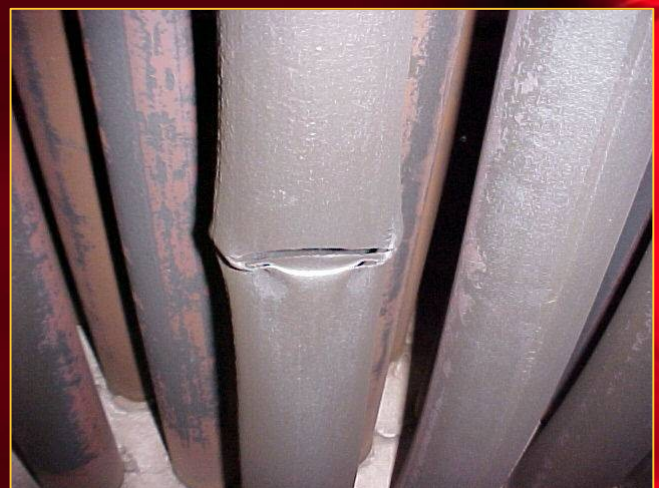
Buckled Tube with Associated Failure
