Issue No.14

April 2006

Overheating & Cooling

Subject: Localized Over Heat & Associated Failures in Stainless Steel Pipe

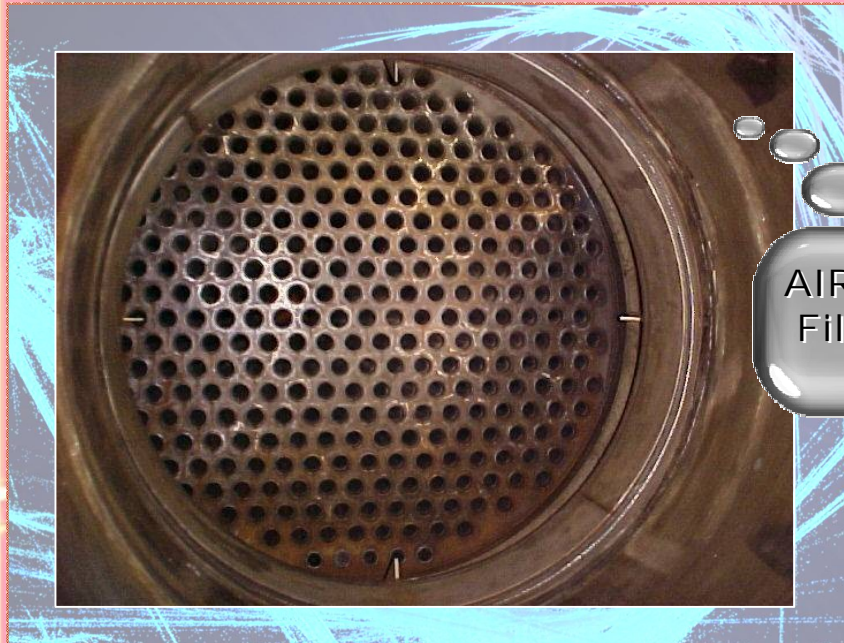
AIR HEATER
Filtered Air
Inlet

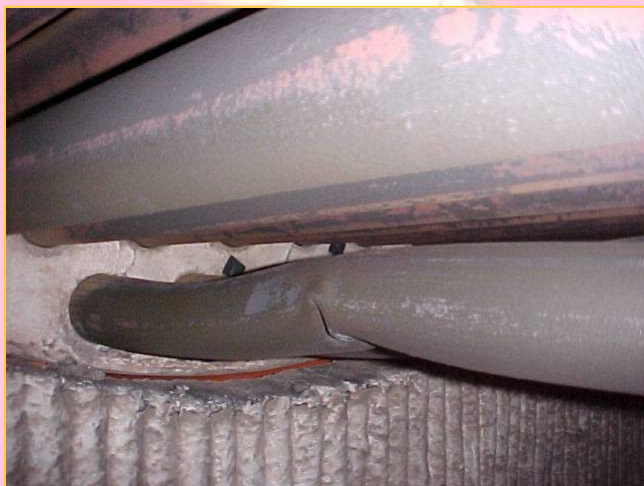
View of Pipe Directly Adjacent to Inlet Hot Combustion Gases

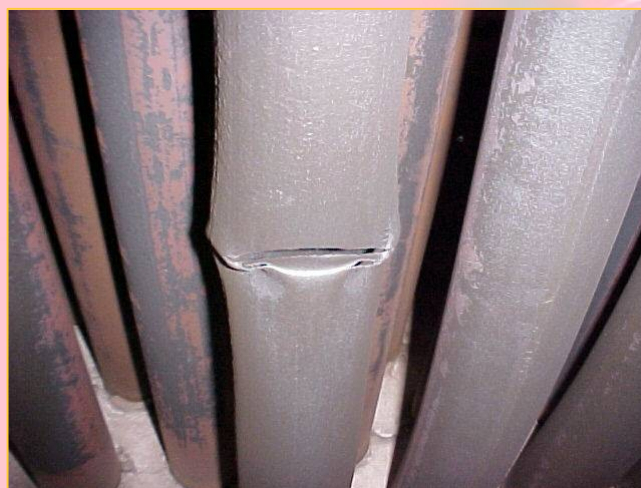
Buckled Tube with Associated Failure
