# Monthly Chronicle

June 2006

## Magnetec Inspection, Inc.

## Subject: O.D. Cooling Water Corrosion in Slurry Bundle

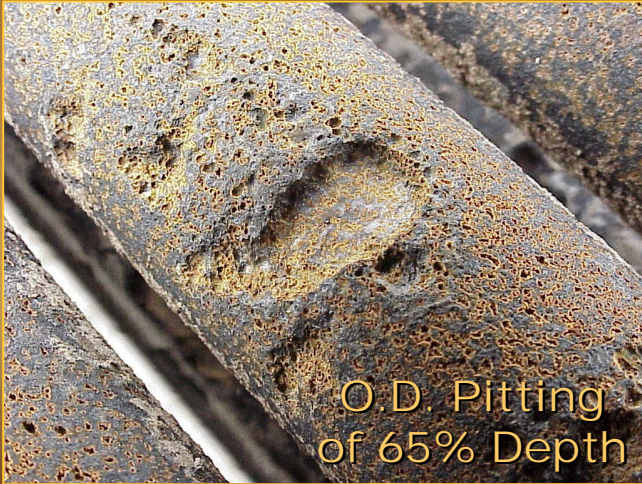
O.D. Pitting  
of 65% Depth

Severe O.D. Corrosion  
Cooling Water Corrosion

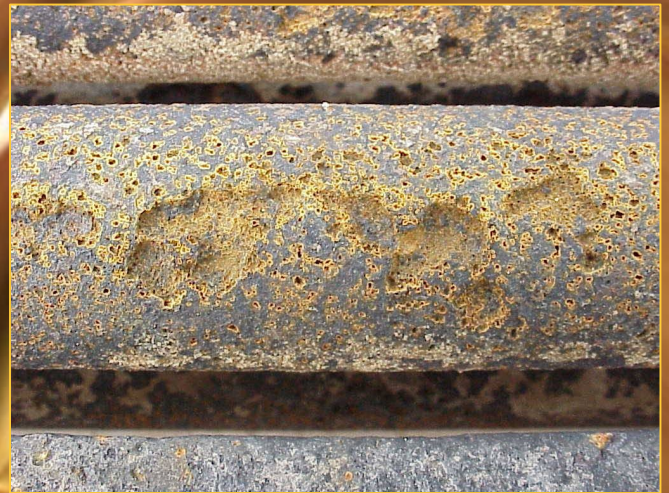
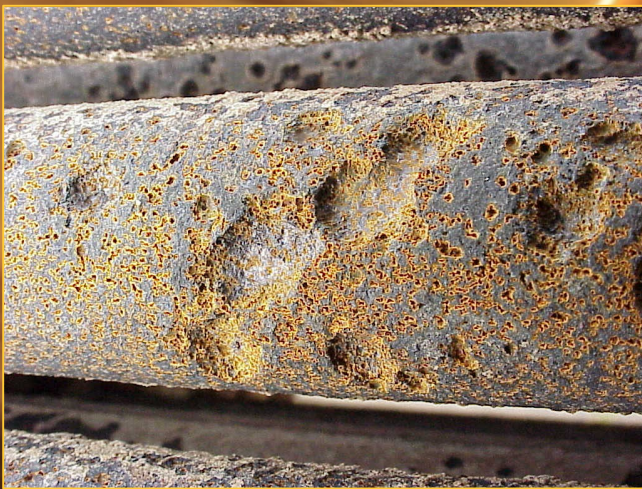
Multiple Pit  
Initiation Sites

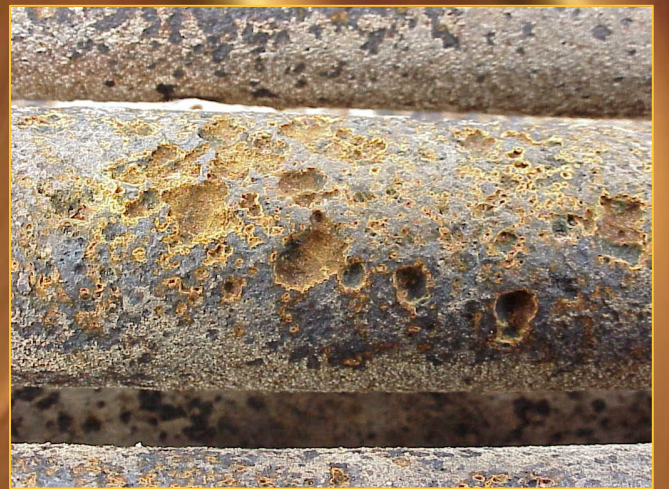
Note: Numerous Initiation  
Sites along Tube Axis

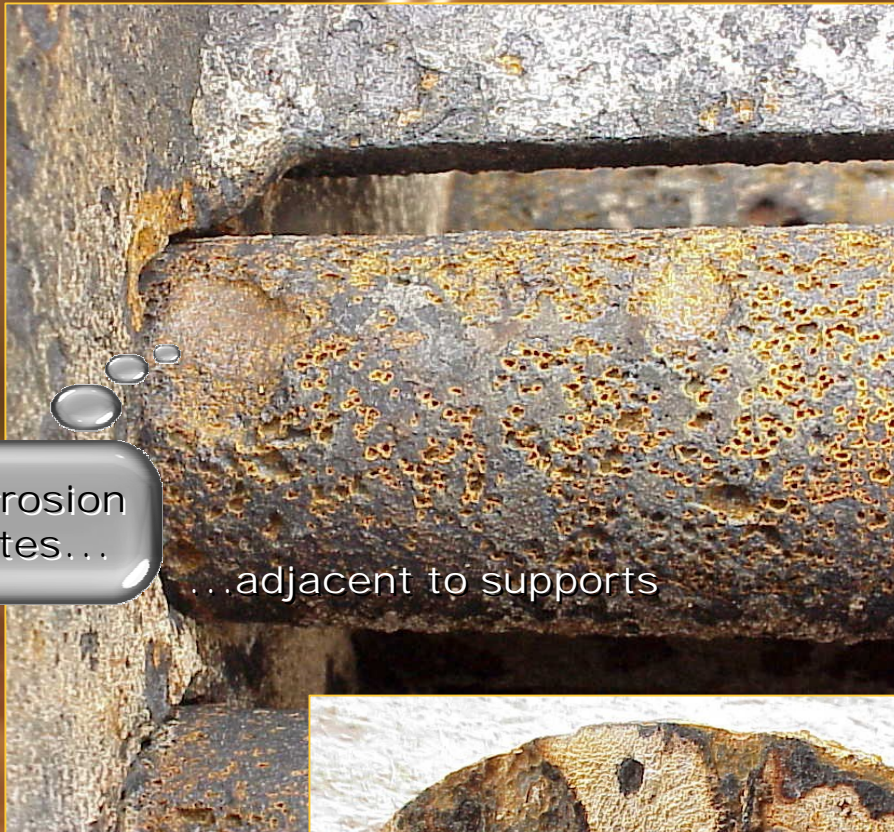
Corrosion Sites...

...adjacent to supports

Tube Support Location

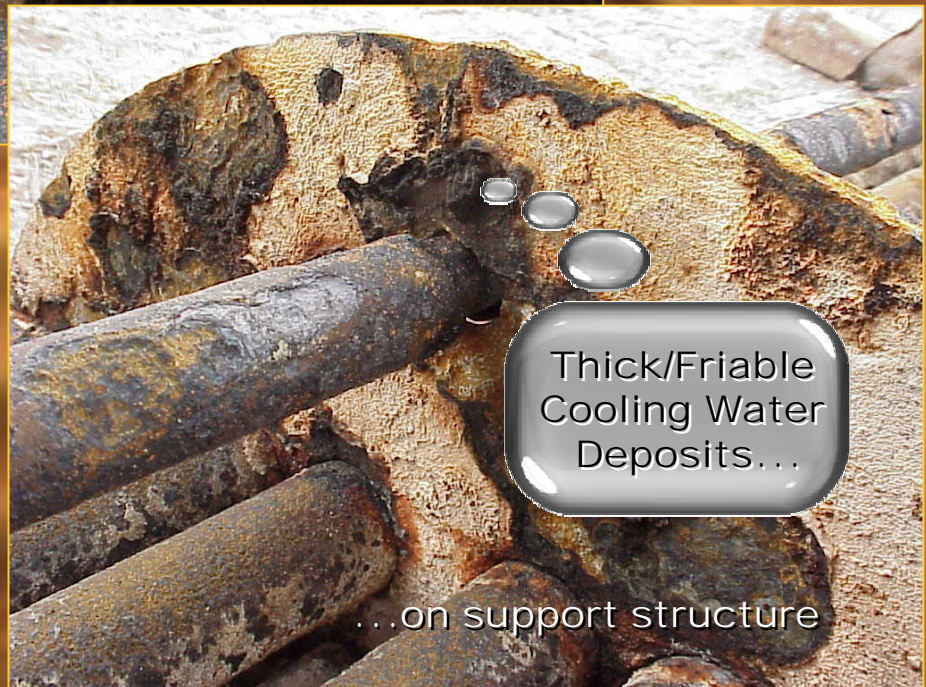
Thick/Friable Cooling Water Deposits...

...on support structure

sion rates will accelerate in correlation with deposit deposition rate and service life. Increased deposit depths raise the heat gradient across the tube wall due to poor heat transfer and increase the rate of deposit deposition. For purpose of this discussion, the term high heat gradient is heat levels at and/or slightly below the recommended operating temperature for cooling water bundles. Based on the inspection results the bundles were recommended to be replaced with SA-179 seamless material, put on an increased cleaning cycle and inspected on a regular basis to track the corrosion rate. Recommendations were made to retrofit the bundles so they could be back flushed during operation.
