Monthly Chronicle

Issue No.15

June 2006

Subject: O.D. Cooling Water Corrosion in Slurry Bundle

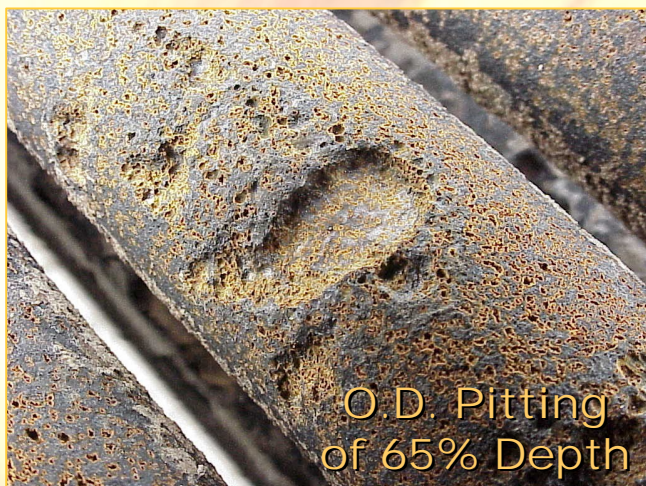
O.D. Pitting
of 65% Depth

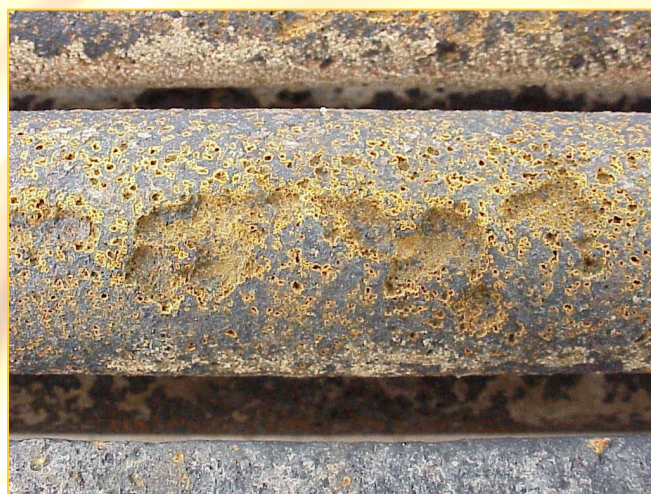
Severe O.D. Corrosion
Cooling Water Corrosion

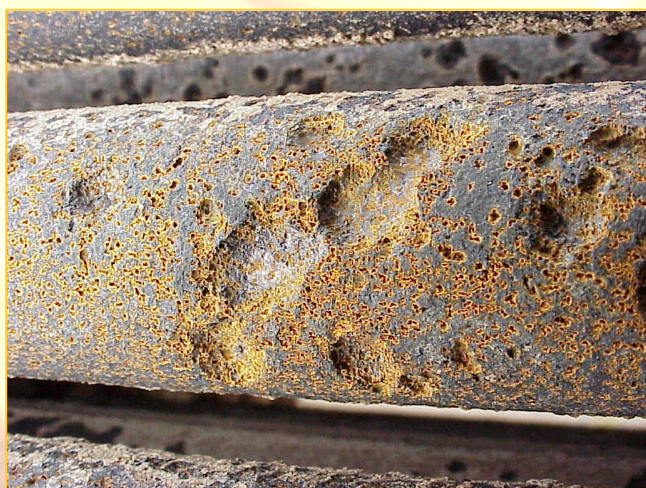
Multiple Pit
Initiation Sites

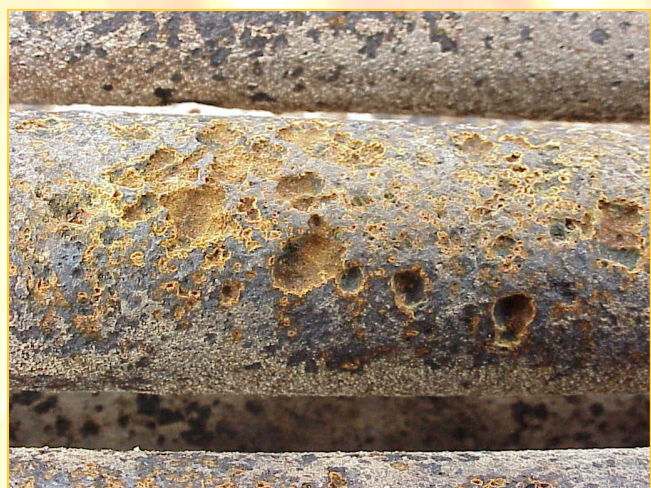
Note: Numerous Initiation
Sites along Tube Axis

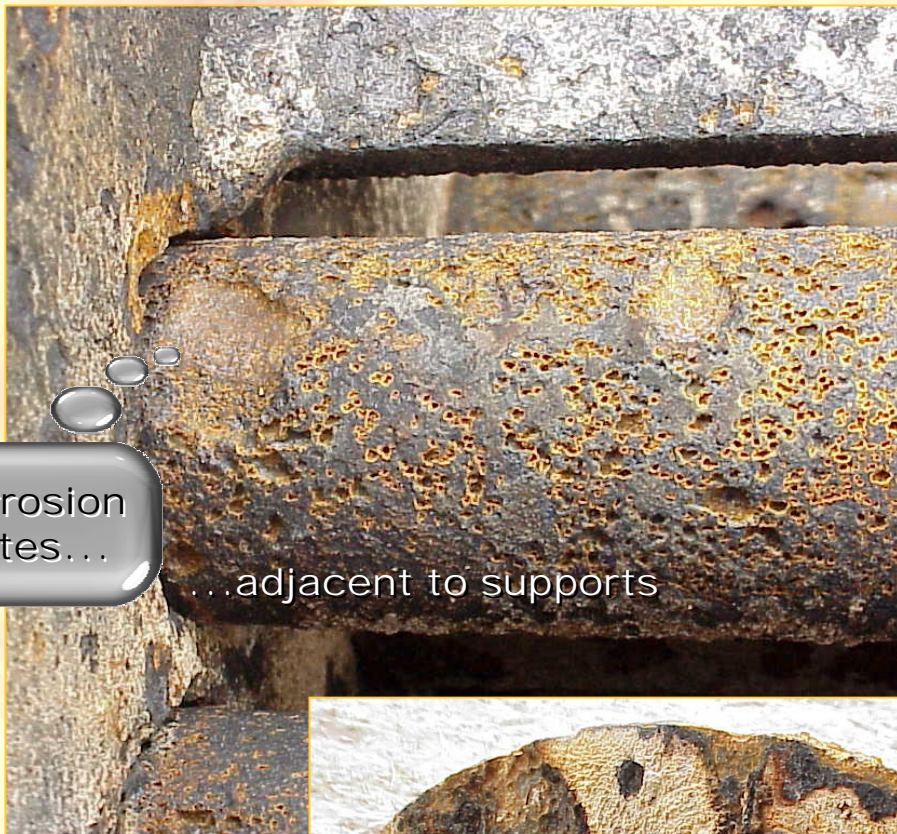
Tube Support Location

Corrosion Sites...

...adjacent to supports

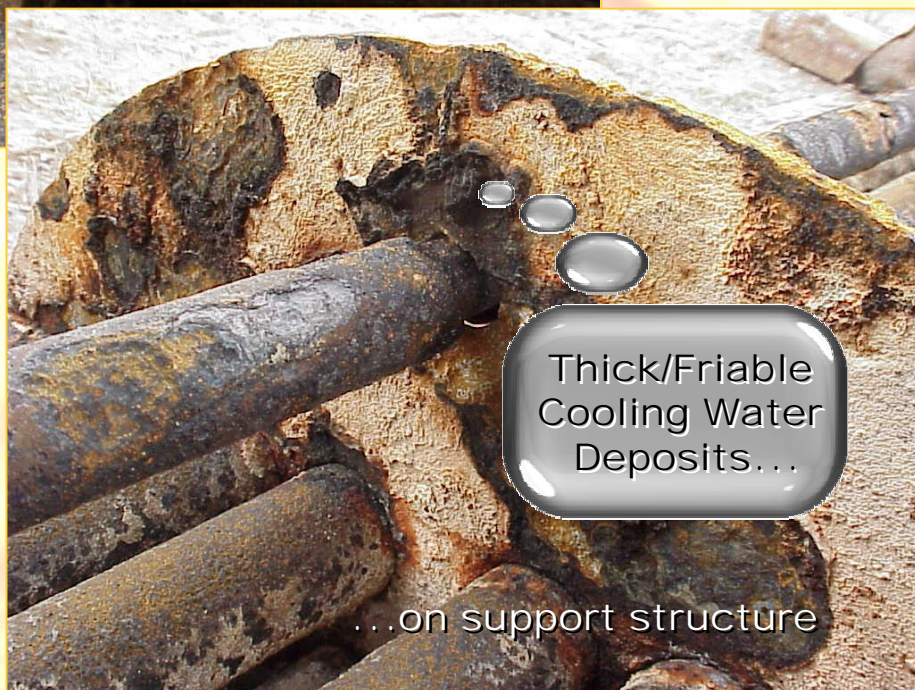
Thick/Friable Cooling Water Deposits...

...on support structure

sion rates will accelerate in correlation with deposit deposition rate and service life. Increased deposit depths raise the heat gradient across the tube wall due to poor heat transfer and increase the rate of deposit deposition. For purpose of this discussion, the term high heat gradient is heat levels at and/or slightly below the recommended operating temperature for cooling water bundles. Based on the inspection results the bundles were recommended to be replaced with SA-179 seamless material, put on an increased cleaning cycle and inspected on a regular basis to track the corrosion rate. Recommendations were made to retrofit the bundles so they could be back flushed during operation.
