# Monthly Chronicle

Issue No.18

June 2007

## Subject: High Temperature Sulfidic Corrosion

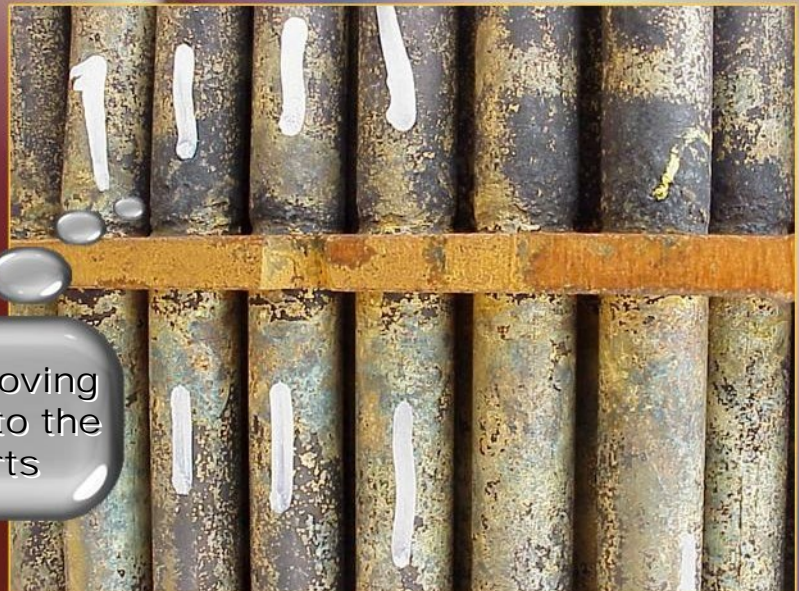
Bottom Row of  
Tubes near U-  
bend

The bundles were in relatively clean service prior to being moved to the current service and corrosion rates in the previous service had been minimal during the life of the bundle. The new service is naphtha with water vapor and significant sulfur content. The tubes were detected with severe O.D. corrosion in the form of under deposit pitting and localized grooving at the support locations. It appears that the sour acid gas condenses at the support locations and forms a sulfide scale where aggressive anodic corrosion cells establish with associated pitting and groove type defects. The grooving is similar the non-condensable gases (Ammonia- NH<sub>3</sub>) that form at temperature gradient/dew points in steam systems. The condensed acid gas H<sub>2</sub>S at the support locations forms individual pit sites that connect with continued service and leave the appearance of the grooving at the support locations. Sulfidic acid corrosion and high temperature crude corrosivity in general is a reliability issue in terms of corrosion in process heat exchangers. The presence of sulfur compounds considerably increases corrosion in the high temperature parts of the process units. The difference in process conditions, materials of construction and corrosion constituents in a specific process flow increases the problem of correlating corrosion within a unit to a certain single aspect of unit operation.

Note: Grooving  
adjacent to the  
supports

The following recommendations were made to control the acid gas corrosion.

- Water injection
- Backflushing
- Filming agent
- Alloy upgrade
- Increase regular cleaning cycles
- Dedicated spare exchangers to be installed while offline cleaning is performed

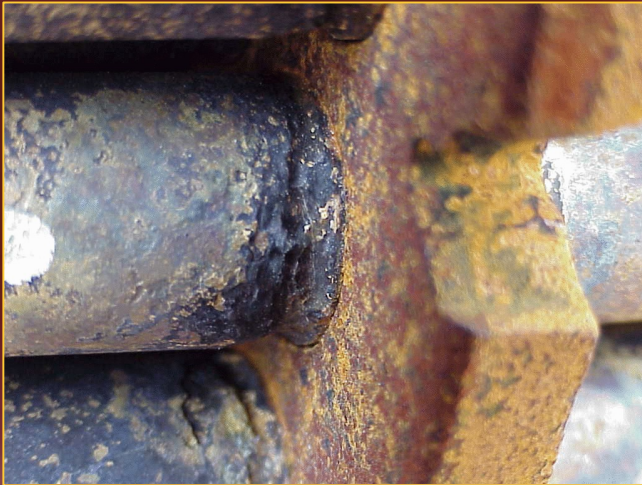
Grooving at support location

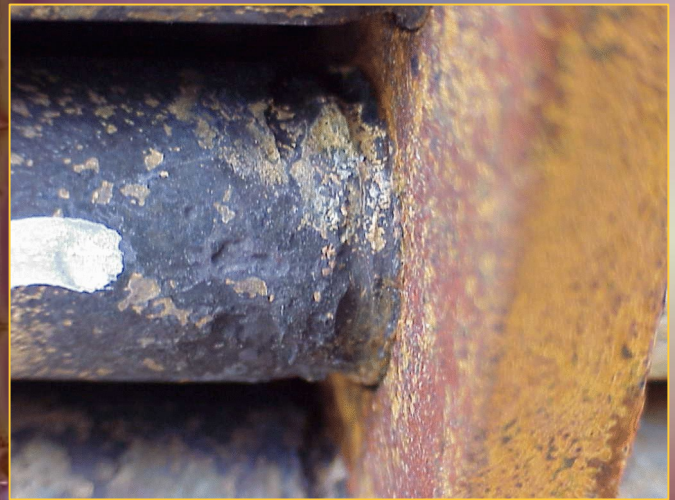
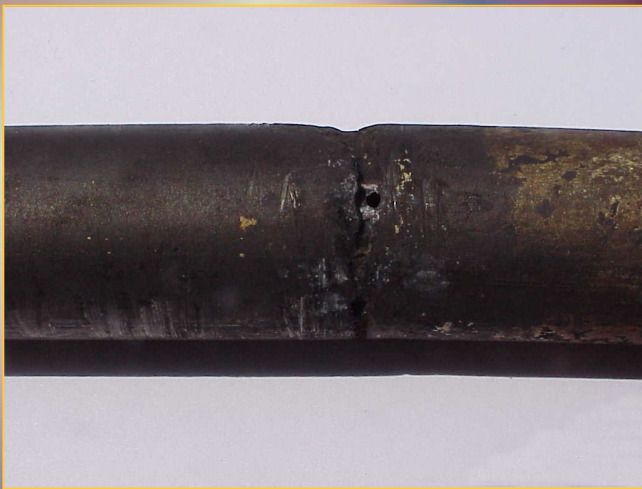
Removed tube sample:  
Note failure in tube

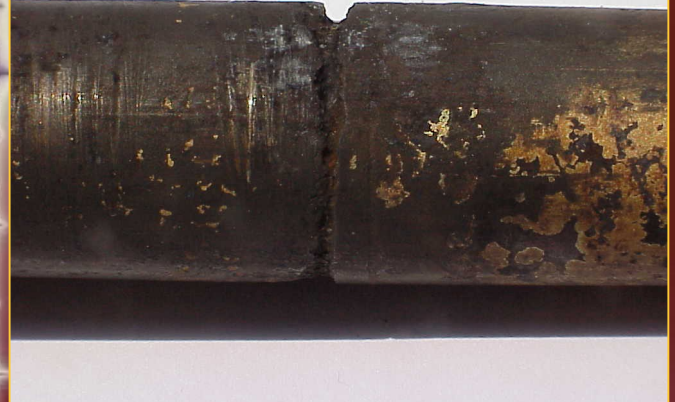
Severe groove depth adjacent to edge of support.
