Monthly Chronicle

Issue No.18

June 2007

Subject: High Temperature Sulfidic Corrosion

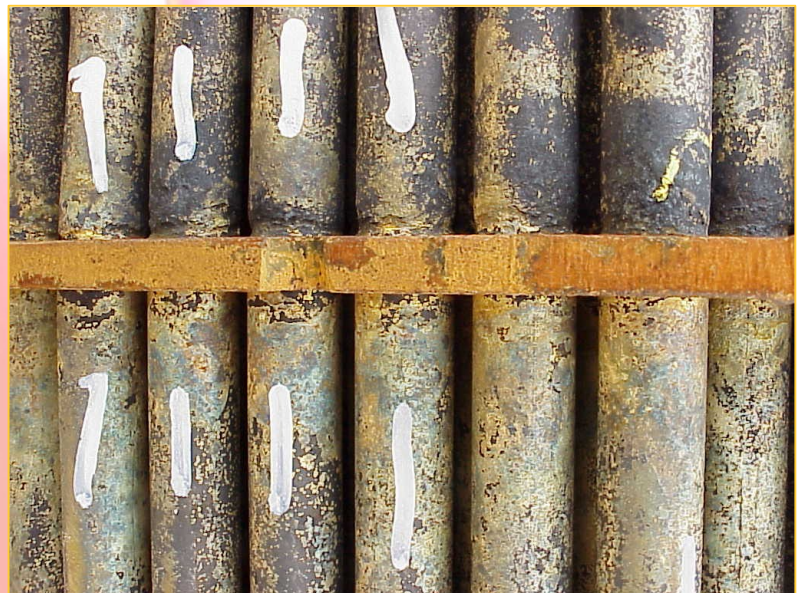
Bottom Row of
Tubes near U-
bend

The bundles were in relatively clean service prior to being moved to the current service and corrosion rates in the previous service had been minimal during the life of the bundle. The new service is naphtha with water vapor and significant sulfur content. The tubes were detected with severe O.D. corrosion in the form of under deposit pitting and localized grooving at the support locations. It appears that the sour acid gas condenses at the support locations and forms a sulfide scale where aggressive anodic corrosion cells establish with associated pitting and groove type defects. The grooving is similar the non-condensable gases (Ammonia- NH₃) that form at temperature gradient/dew points in steam systems. The condensed acid gas H₂S at the support locations forms individual pit sites that connect with continued service and leave the appearance of the grooving at the support locations. Sulfidic acid corrosion and high temperature crude corrosivity in general is a reliability issue in terms of corrosion in process heat exchangers. The presence of sulfur compounds considerably increases corrosion in the high temperature parts of the process units. The difference in process conditions, materials of construction and corrosion constituents in a specific process flow increases the problem of correlating corrosion within a unit to a certain single aspect of unit operation.

Note: Grooving
adjacent to the
supports

The following recommendations were made to control the acid gas corrosion.

- Water injection
- Backflushing
- Filming agent
- Alloy upgrade
- Increase regular cleaning cycles
- Dedicated spare exchangers to be installed while offline cleaning is performed

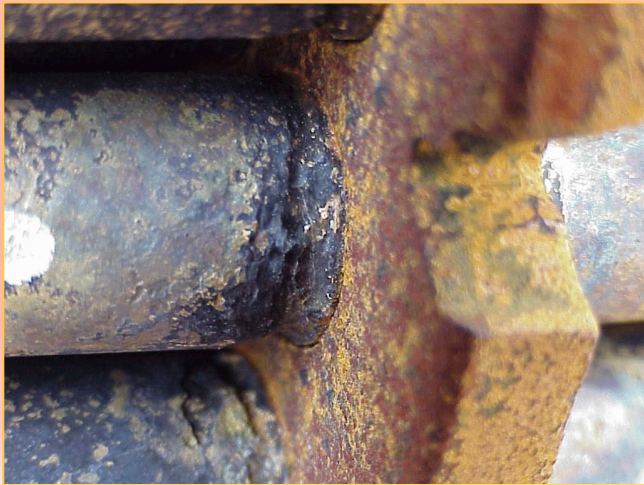
Grooving at support location

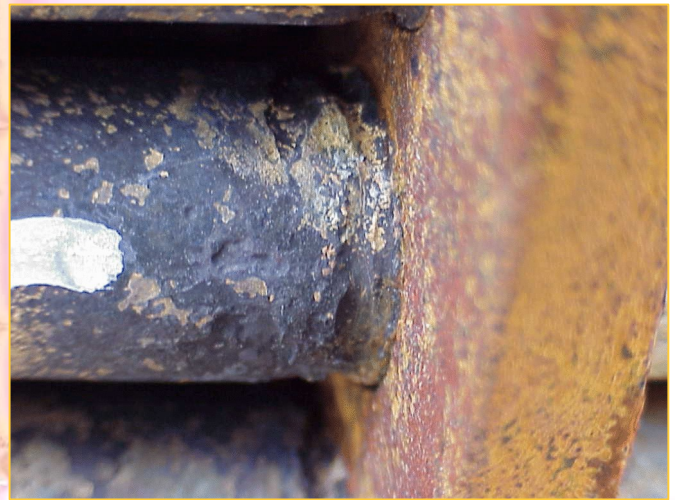
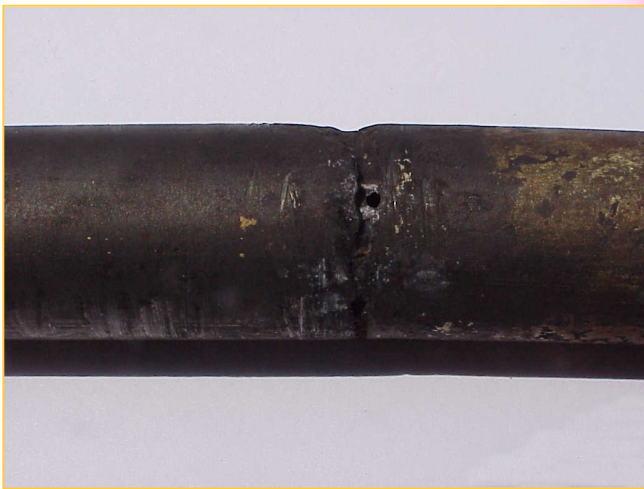
Removed tube sample:
Note failure in tube

Severe groove depth adjacent to edge of support.
