Magnetec Monthly Chronicle

Noteworthy Discovery On Site During Inspection of HE-1311

HE-1311 – Turbine Exhaust Condenser Background:

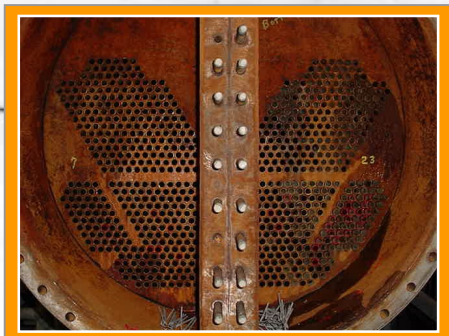
A rather perplexing event has occurred which mainly brings rise to the question of how or what caused the results. Collapsed tubing at the roll of 63 tubes and cracks to 2 tubes in what is otherwise good condition material (as per ECT / supplemental inspection processes performed by Magnetec Inspection) appearing still pure and ductile with otherwise little corrosion/problems or conditions other than what might be expected in a Condenser of this design. There was little to no significant corrosion to note in the region of the failed tubes. No Dezincification bad enough to aid in cracking. After considering Eddy Current inspection results (which indicated only light I.D. pitting to some tubes mainly toward Exchanger bottom rows & De-aerator section) and examining the condition of the material of a sample tube section extracted from the Condenser it was surmised that there should be no areas where pit initiated cracking would have stemmed. Examining the crack face of the sample sections available it appeared that no pitting was related to the cracking. It appears that no O.D. condensate grooving would have initiated the cracks and as it was the cracks in the 2 failed tubes

were apparently away from support locations as per sample tube sections extracted. What may have caused the collapsed areas in the roll of 63 tubes? This collapsed effect is something that apparently had to have been initiated from some event which occurred on the shell side. The collapses are present more towards the rear of the roll area in each tube affected. It is Magnetec Inspection's hypothesis that there was an immensely severe event that caused this all to occur. After some investigation (which includes reports from operations personnel about an event approximately 8-12 months ago which may have caused all this), it was considered that maybe there was a severe event involving a shocking condensate/steam hammer mechanism. Reports from operations confirm such an event which could have been the culprit. Witnesses stated that they saw piping (from outside the building there) which ultimately feeds the Condenser move/thrust many inches upon an accidental surge of steam/condensate upon a line possibly rather full of condensate (at the condenser end) at that time. This may have caused a hammer effect at the circuit end within

the Condensers limits where so much energy would have to be absorbed. Collapsed and cracked tubing resulted.

See the collapsed area of the tube?

Recommendations:
This was considered an isolated incident. The tubes with the collapses should be replaced and/or plugged and the unit Returned to extended Service.

Actions Taken:
The affected tubes were individually replaced and 3 tubes were plugged. The unit was Returned to Service.

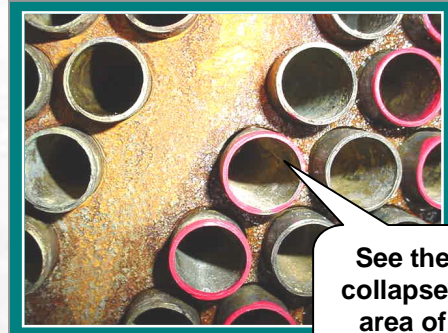
See where a collapse caused a breach?

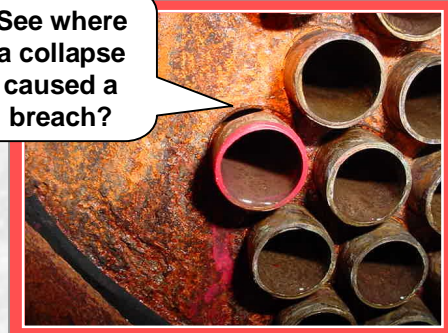
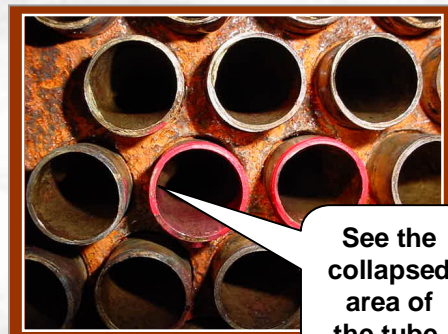
See the collapsed area of the tube.

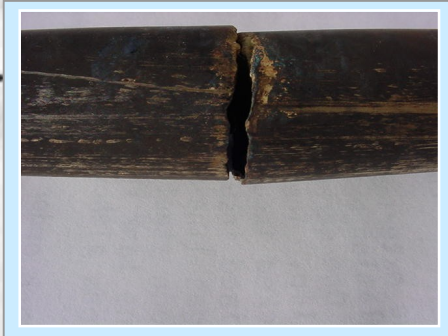
Sections from the Cracked Tubes

I.D. Surface from Sample Tube Section

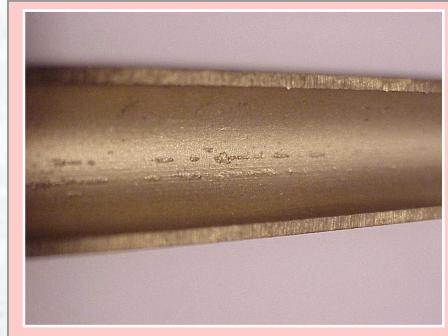
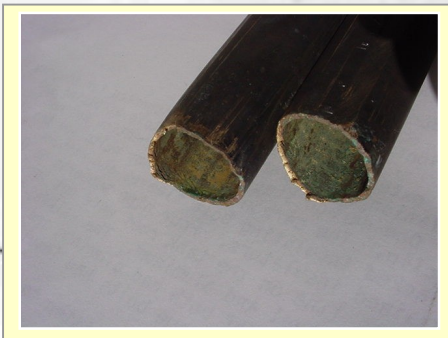
O.D. Surface from Sample Tube Section
