# Magnetec Monthly Chronicle

## Noteworthy Discovery On Site During Inspection of HE-1311

HE-1311 – Turbine Exhaust Condenser Background:

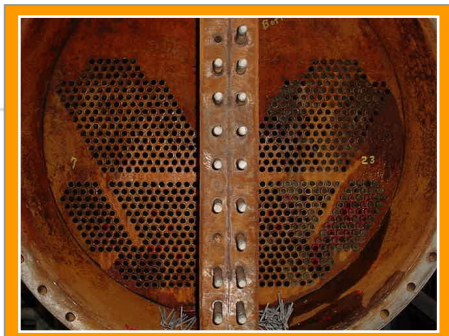
were apparently away from support locations as per sample tube sections extracted. What may have caused the collapsed areas in the roll of 63 tubes? This collapsed effect is something that apparently had to have been initiated from some event which occurred on the shell side. The collapses are present more towards the rear of the roll area in each tube affected. It is Magnetec Inspection's hypothesis that there was an immensely severe event that caused this all to occur. After some investigation (which includes reports from operations personnel about an event approximately 8-12 months ago which may have caused all this), it was considered that maybe there was a severe event involving a shocking condensate/steam hammer mechanism. Reports from operations confirm such an event which could have been the culprit. Witnesses stated that they saw piping (from outside the building there) which ultimately feeds the Condenser move/thrust many inches upon an accidental surge of steam/condensate upon a line possibly rather full of condensate (at the condenser end) at that time. This may have caused a hammer effect at the circuit end within

the Condensers limits where so much energy would have to be absorbed. Collapsed and cracked tubing resulted.

See the collapsed area of the tube?

Recommendations:  
**This was considered an isolated incident. The tubes with the collapses should be replaced and/or plugged and the unit Returned to extended Service.**

Actions Taken:  
**The affected tubes were individually replaced and 3 tubes were plugged. The unit was Returned to Service.**

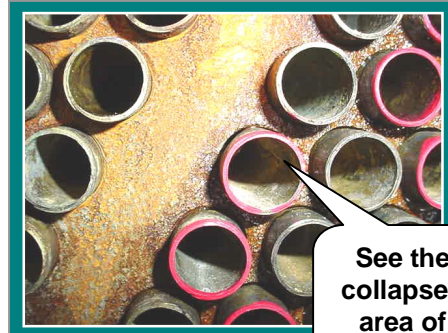
See where a collapse caused a breach?

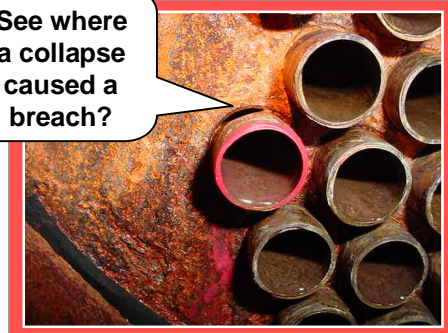
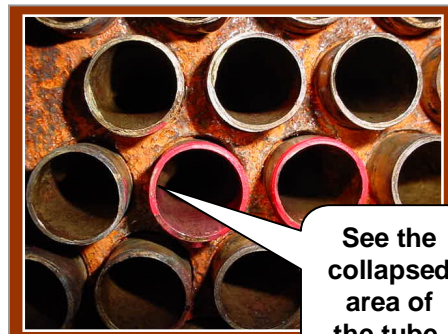
See the collapsed area of the tube.

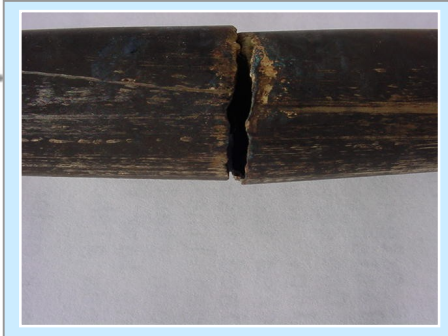
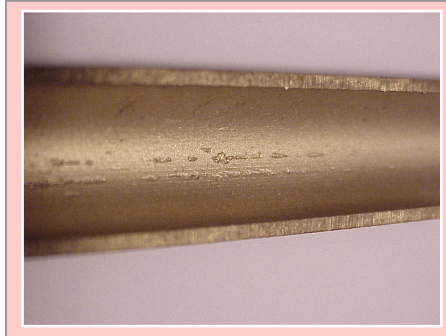
**Sections from the Cracked Tubes**

I.D. Surface from Sample Tube Section

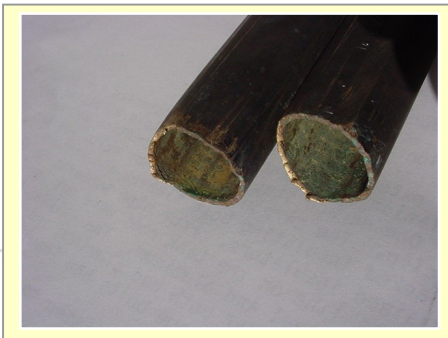
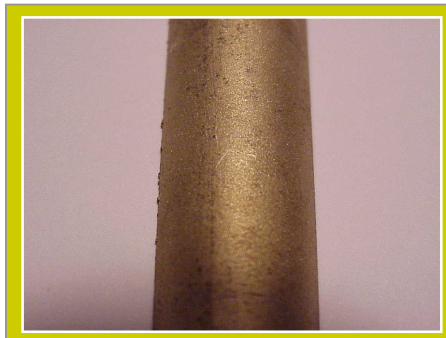
O.D. Surface from Sample Tube Section
