# Magnetec Monthly Chronicle

Issue No.2  
Feb 2005

1 Failed Tube in 10/2004 with a Lost Opportunity of \$150,000 Dollars  
The Exchanger is Found in a Major Mid-eastern Refinery.  
**The bundle was inspected to aid in a post failure investigation and document the primary failure corrosion mechanism.**  
**The exchanger operates as a WFO process Solvent Aftercooler with tube side cooling water and shell side WFO solvent. The tubing consists of 354 U-tubes X .083 min wall X SA-214 X 20 Foot long.**

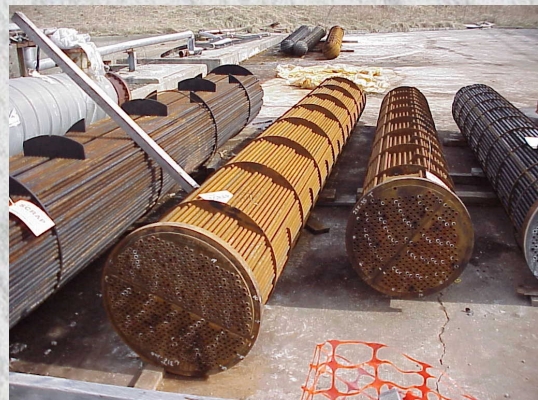
The bundle had been retubed/replaced 4 times in the 24 year life cycle with many failures and unreliable service. The inspection was performed on 25% of the tubing and the failed tube section. The failed tube and actual failure section was removed after the failure location was determined by the RFET inspection. The tubing was detected with I.D. under deposit cooling water corrosion (Concentration cell initiated) due to the heavy lay-out of deposits. The pitting was found as multiple pit locations of heavy concentration along the tube length. The actual failure was found to be seam weld attack and penetration along the seam. Seam welded type tubing is considered poor material for cooling water environments due to the preferential attack to the weld to parent tube material. Based on the age of the bundle at the time of failure (6 years) this type of failure is not uncommon and accelerated corrosion and additional failures would have been expected. Cooling water bundles generally provide 10 years of service before problems are expected.

The bundle was determined to be unsuitable for continued service and was scrapped. The material of the replacement bundle was upgraded to SA-179 (Seamless) and the bundle was put on an accelerated cleaning cycle to aid in removal of cooling water deposit lay-out.

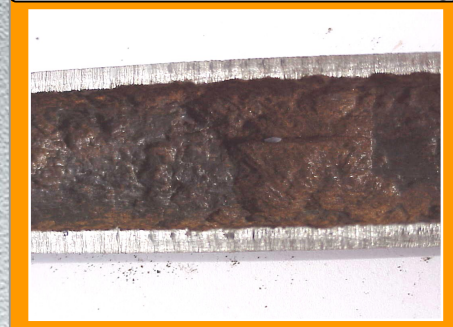
**Failure  
at seam  
weld**

Tube Section Prior to Sandblasting

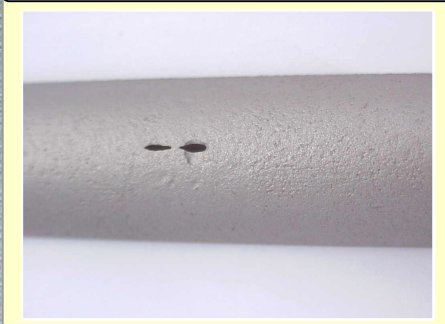
Same Tube After Sandblasting

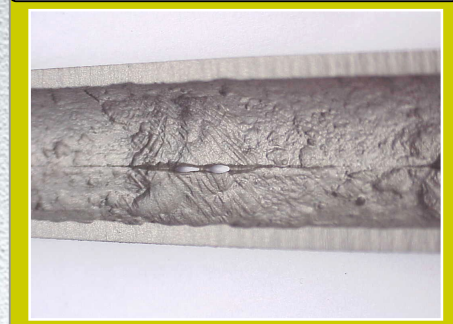
Same Tube After Sandblasting
