Magnetec Monthly Chronicle

" From the Field "

Issue No.2
Feb 2005

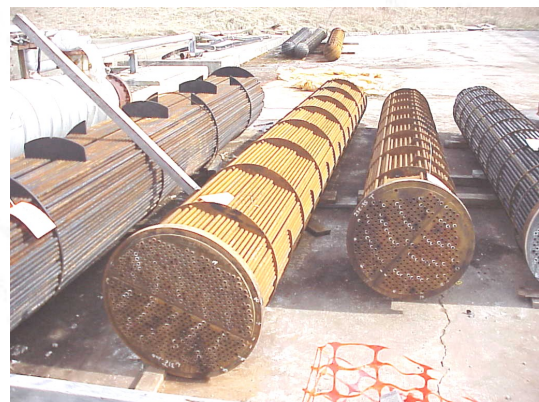
1 Failed Tube in 10/2004 with a Lost Opportunity of \$150,000 Dollars
The Exchanger is Found in a Major Mid-eastern Refinery.
The bundle was inspected to aid in a post failure investigation and document the primary failure corrosion mechanism.
The exchanger operates as a WFO process Solvent Aftercooler with tube side cooling water and shell side WFO solvent. The tubing consists of 354 U-tubes X .083 min wall X SA-214 X 20 Foot long.

The bundle had been retubed/replaced 4 times in the 24 year life cycle with many failures and unreliable service. The inspection was performed on 25% of the tubing and the failed tube section. The failed tube and actual failure section was removed after the failure location was determined by the RFET inspection. The tubing was detected with I.D. under deposit cooling water corrosion (Concentration cell initiated) due to the heavy lay-out of deposits. The pitting was found as multiple pit locations of heavy concentration along the tube length. The actual failure was found to be seam weld attack and penetration along the seam. Seam welded type tubing is considered poor material for cooling water environments due to the preferential attack to the weld to parent tube material. Based on the age of the bundle at the time of failure (6 years) this type of failure is not uncommon and accelerated corrosion and additional failures would have been expected. Cooling water bundles generally provide 10 years of service before problems are expected.

The bundle was determined to be unsuitable for continued service and was scrapped. The material of the replacement bundle was upgraded to SA-179 (Seamless) and the bundle was put on an accelerated cleaning cycle to aid in removal of cooling water deposit lay-out.

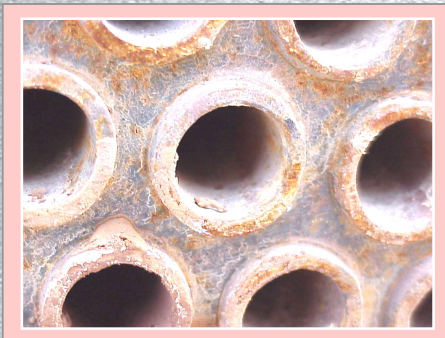
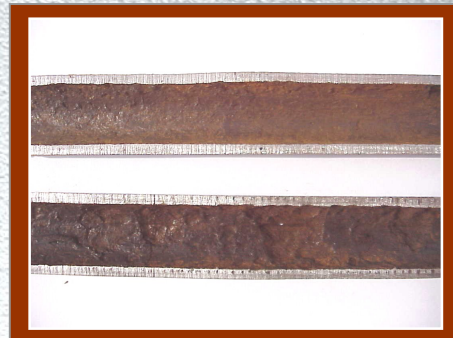
Tube Section Prior to Sandblasting

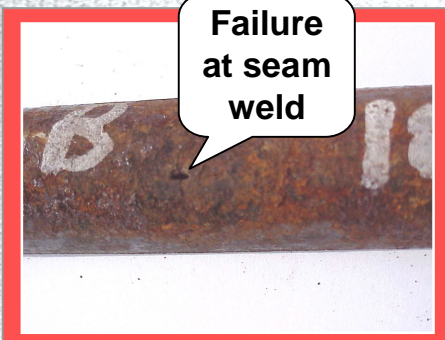
Failure
at seam
weld

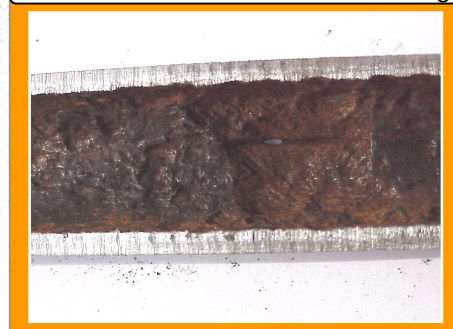
Same Tube After Sandblasting

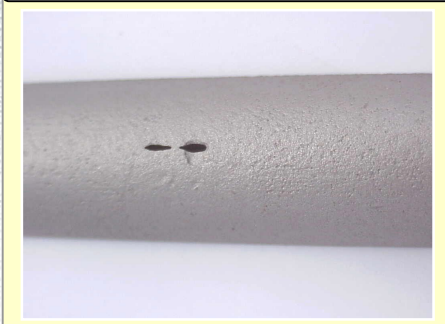
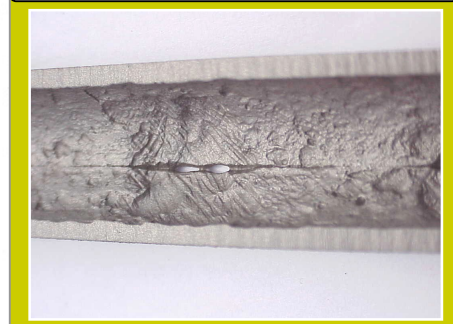
Same Tube After Sandblasting
