Magnetec Monthly Chronicle

Issue No.3 " FROM THE FIELD " March 2005

We were caught off guard with that one !!!

It was an Expected 5 Year Operating Timeframe
The exchanger is found in a major Southern Gulf Coast refinery. The bundle was inspected to determine active corrosion mechanism and to aid in life expectancy and service reliability for an expected 5 year operating time frame.

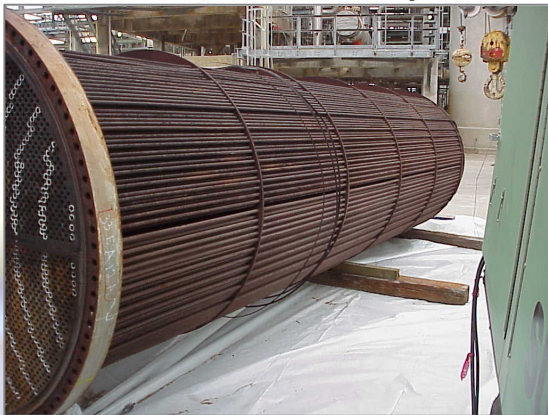
The exchanger had no failed tubes prior to inspection and no history of tube related problems. The material is carbon steel SA-179. The previous visual inspection performed 2 years earlier through an inspection man-way in the shell found adverse conditions/corrosion to the tubing. The bundle was not expected to

have any corrosion problems and the inspection was planned as a cursory look at the bundle condition as the shell was being inspected on its 10 year cycle. The inspection was performed on 25% of the tubing across the entire

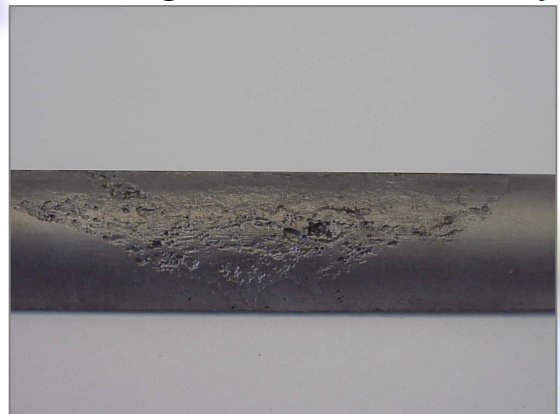
bundle matrix. The tubing was found to contain O.D. pitting type corrosion mechanism (Oxygen pitting) to the top 1/2 of the tube matrix with defect depths of 60% in most cases. A corroded tube section was removed after the inspected to confirm the inspection results and provide tube sections for analysis. The tubing was found with heavy

fouling and tubercle-like deposits (Phosphates) and under deposit corrosion (Concentration cell initiated) due to the heavy lay-out of entrained constituents found in the condensate.

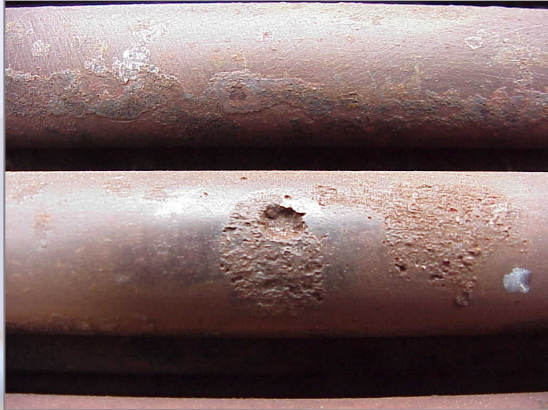
The pitting was found as multiple pit locations of heavy concentration along the tube length and across the bundle tube matrix with the most defect concentrations and severity on the top half of the exchanger. Based on the age of the bundle at the time of inspection (10

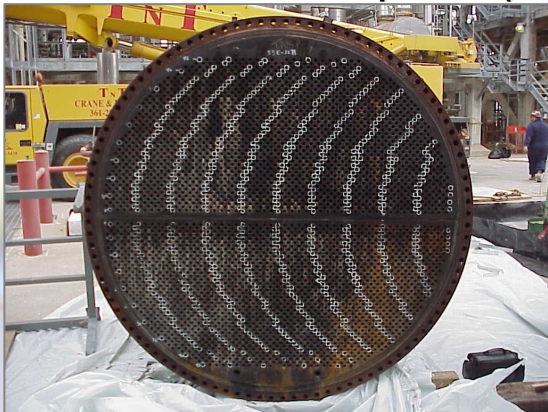
years) and the severe corrosion attack documented the bundle was considered in poor service condition and was recommended for a retube during the turnaround. The exchanger was expected to have accelerated corrosion and possible tube failures with high unit impact

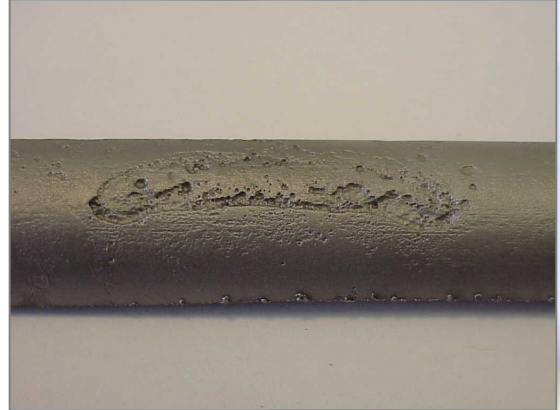
and lost opportunity from continued extended service. Operating conditions such as condensate make-up, Water chemistry, Oxygen content, temperature, and contaminants in condensate supply all contribute to the corrosion rate which can vary the expected life to a high degree. The sister bundle was also inspected and determined to be unsuitable for continued service and was also scrapped.
