Magnetec Monthly Chronicle

Issue No.3
Mar 2005

We were caught off guard with that one !!!

It was an Expected 5 Year Operating Timeframe
The exchanger is found in a major Southern Gulf Coast refinery. The bundle was inspected to determine active corrosion mechanism and to aid in life expectancy and service reliability for an expected 5 year operating time frame.

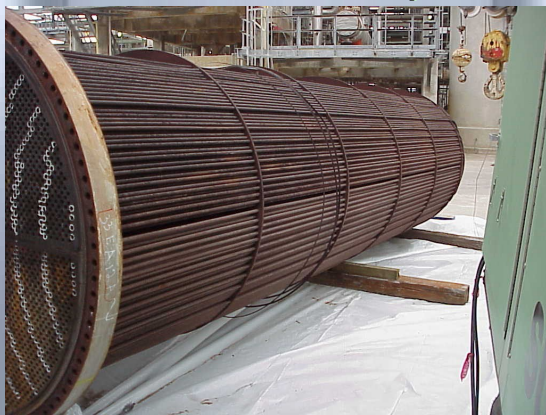
The exchanger had no failed tubes prior to inspection and no history of tube related problems. The material is carbon steel SA-179. The previous visual inspection performed 2 years earlier through an inspection man-way in the shell found adverse conditions/corrosion to the tubing. The bundle was not expected to

have any corrosion problems and the inspection was planned as a cursory look at the bundle condition as the shell was being inspected on its 10 year cycle. The inspection was performed on 25% of the tubing across the entire

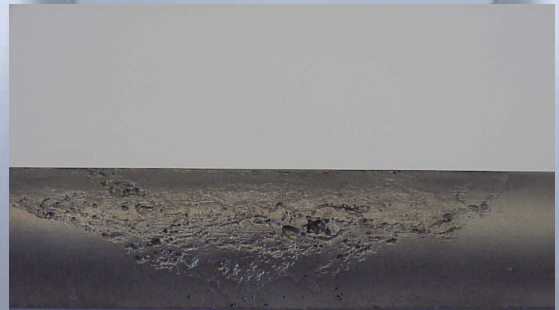
bundle matrix. The tubing was found to contain O.D. pitting type corrosion mechanism (Oxygen pitting) to the top 1/2 of the tube matrix with defect depths of 60% in most cases. A corroded tube section was removed after the inspection to confirm the inspection results and provide tube sections for analysis. The tubing was found with heavy

fouling and tubercle-like deposits (Phosphates) and under deposit corrosion (Concentration cell initiated) due to the heavy lay-out of entrained constituents found in the condensate.

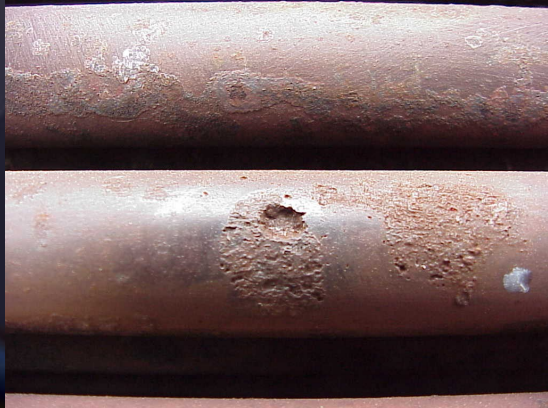
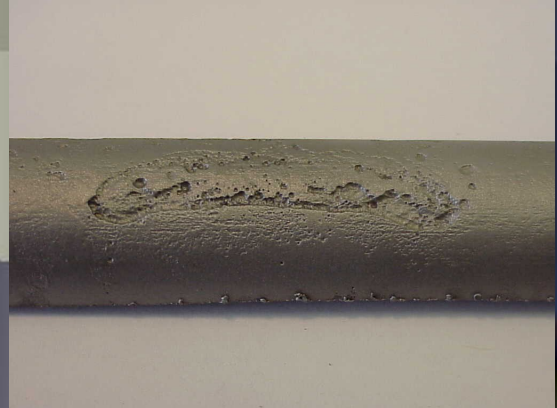
The pitting was found as multiple pit locations of heavy concentration along the tube length and across the bundle tube matrix with the most defect concentrations and severity on the top half of the exchanger. Based on the age of the bundle at the time of inspection (10

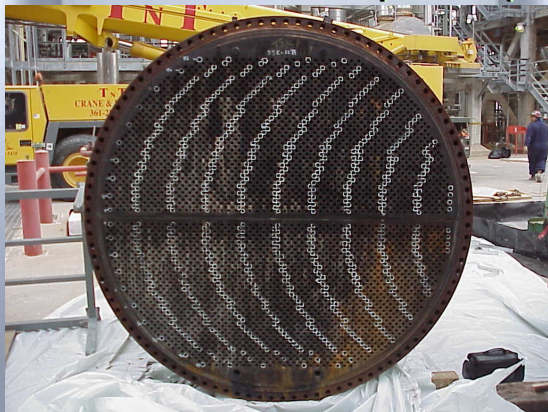
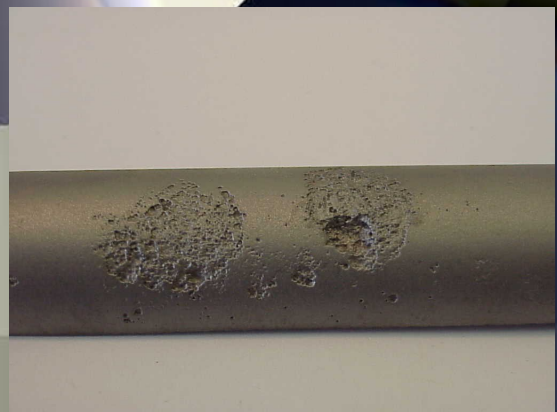
years) and the severe corrosion attack documented the bundle was considered in poor service condition and was recommended for a retube during the turnaround. The exchanger was expected to have accelerated corrosion and possible tube failures with high unit impact

and lost opportunity from continued extended service. Operating conditions such as condensate makeup, Water chemistry, Oxygen content, temperature, and contaminants in condensate supply all contribute to the corrosion rate which can vary the expected life to a high degree. The sister bundle was also inspected and determined to be unsuitable for continued service and was also scrapped.
