Magnetec Monthly Chronicle

Issue No.4 " FROM THE FIELD " April 2005

Surface Cracking in 2205 Duplex Stainless Steel Tubing?

On a recent inspection trip to a Midwest Oil Refinery, Eddy Current Inspection techniques were applied to a Heat Exchanger bundle from the #1 SAT GAS Unit.

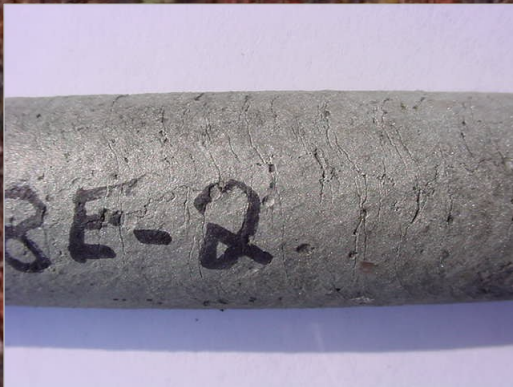
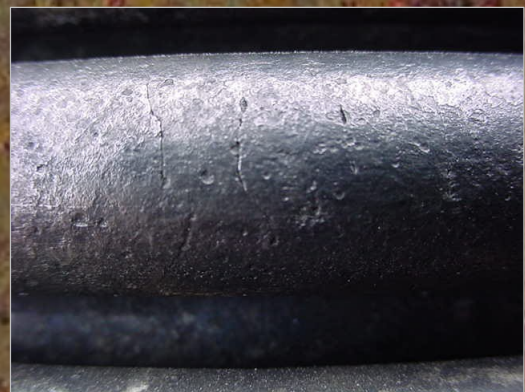
The Exchanger was in service as a Deethanizer Steam Reboiler with a shell side MAWP of 225 psi. at a max. temp. of 250°. ¾" 2205 Duplex Stainless Steel was the material which had replaced the previous SA-789-S31803 tubing reportedly less than 18 months prior. This can be a most common adjustment nowadays if it is felt that the change is necessary and affordable.

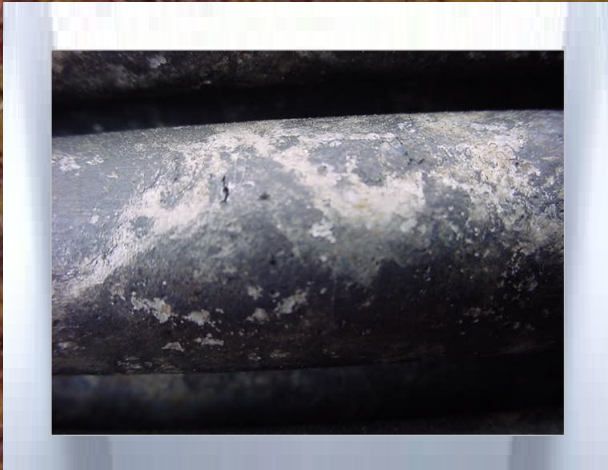
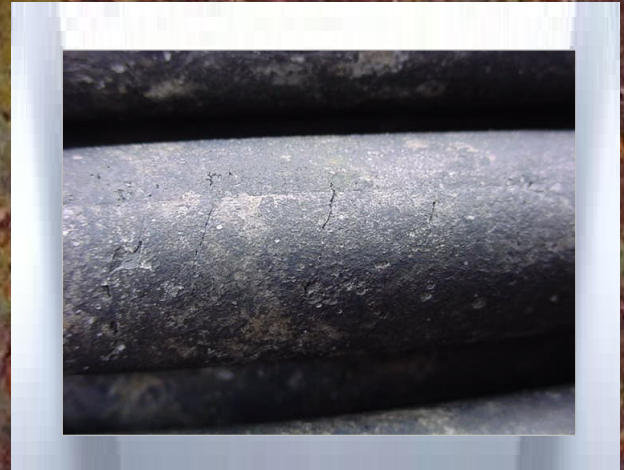
What was found the time of the ECT inspection, was an apparent heat related stress corrosion cracking, which was to an isolated area at the bundle top front. This area had been darkened by a shell side process affect on that region of the bundle. The condition appeared as though it may have been caused due to localized overheating. Numerous small cracks and micro pitting could be seen on the surface of the tubes there. Some cracks appeared as pit initiated. Metallurgical analysis revealed some cracks to be at or above 50% through wall. This had been unexpected and due to the young age of the bundle, and the high corrosion rate, it was decided to Retube the bundle.
