Magnetec Monthly Chronicle

Issue No.4 " FROM THE FIELD " April 2005

Surface Cracking in 2205 Duplex Stainless Steel Tubing?

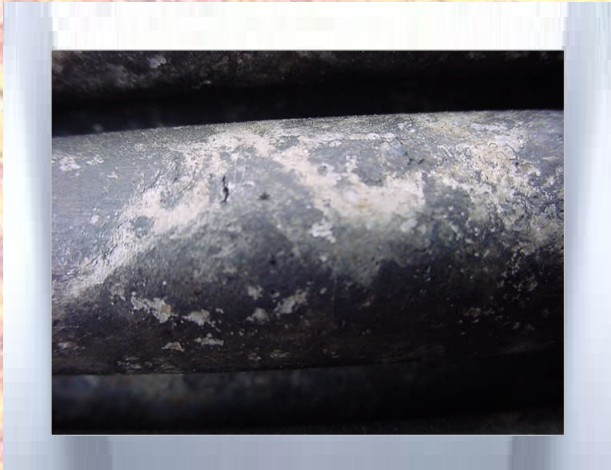
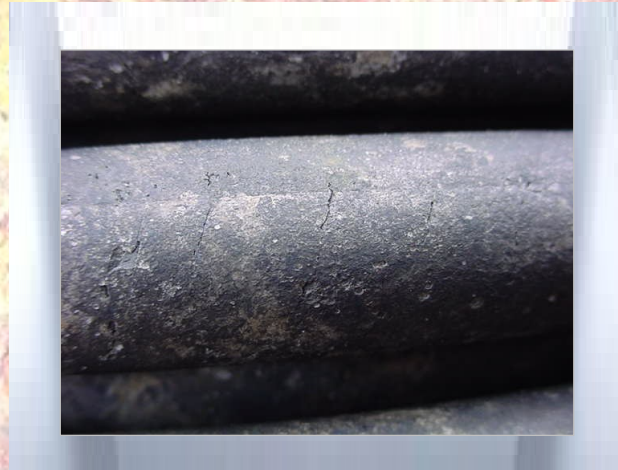
What was found the time of the ECT inspection, was an apparent heat related stress corrosion cracking, which was to an isolated area at the bundle top front. This area had been darkened by a shell side process affect on that region of the bundle. The condition appeared as though it may have been caused due to localized overheating. Numerous small cracks and micro pitting could be seen on the surface of the tubes there. Some cracks appeared as pit initiated. Metallurgical analysis revealed some cracks to be at or above 50% through wall. This had been unexpected and due to the young age of the bundle, and the high corrosion rate, it was decided to Retube the bundle.
