# Magnetec Monthly Chronicle

Issue No.5

May 2005

## What Caused That? Can That Happen?!!!

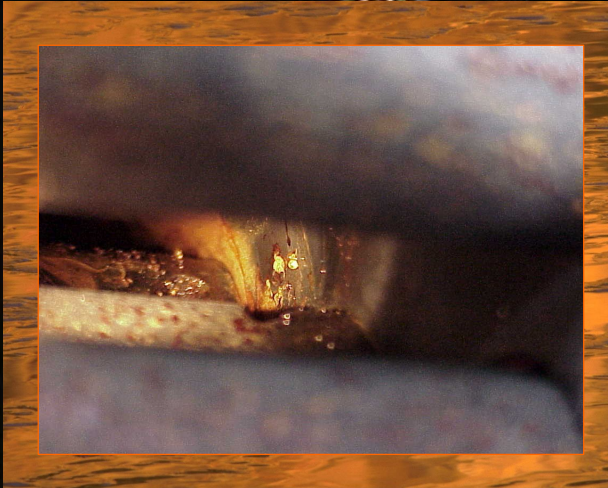
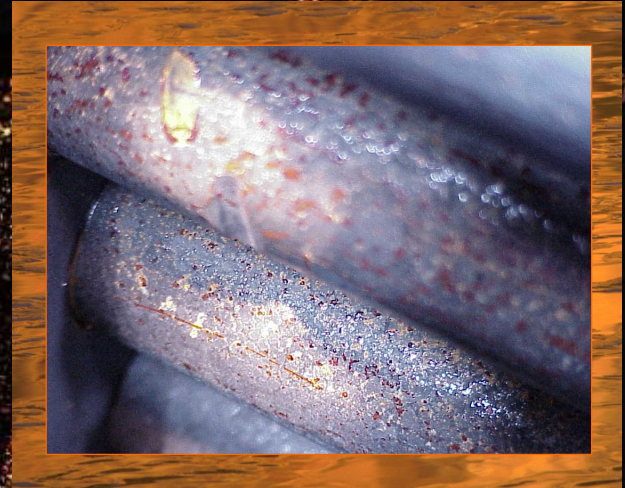
the center shell inlet piping. Based on Video probe visual the failure was a small defect that appeared like a hack saw cut into the tube from the O.D. with full wall penetration. Due to a failed gasket from the channel to shell the bundle was scheduled for pulling which revealed the strange mechanism that caused the failure and adjacent tube damage. Upon pulling of the bundle it was noticed that a stainless spiral-wound gasket had fallen on the top of the tube matrix at the center inlet deflection plate. The gasket was disintegrated with individual windings being spread across the top row of tubes and extending down into the bundle matrix. These single spiral windings had rubbed/fretted the tubing with many very deep defects and caused the thru wall failure. The high shell side flow and sharp side of the stainless gasket winding had cut the tube like a hack saw blade. Based on the amount and location of the gasket pieces found in the tube matrix a 100% inspection of the top 5 rows of tubes was performed and all gasket pieces were removed from the bundle matrix. All tubes with defects

were plugged to returning bundle to service. There was no indication of how the gasket got to its position as the original inlet piping gasket was intact.

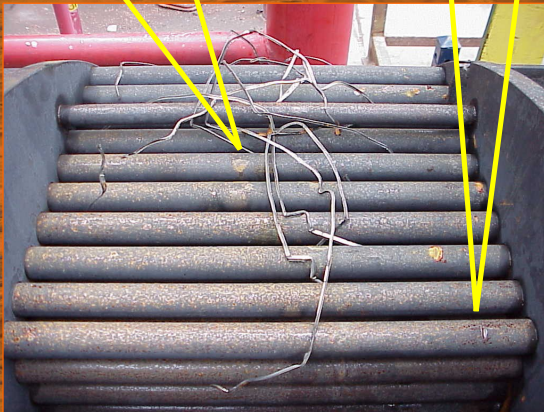
Spiral-wound gasket. As found when bundle was pulled.

Note Defects.

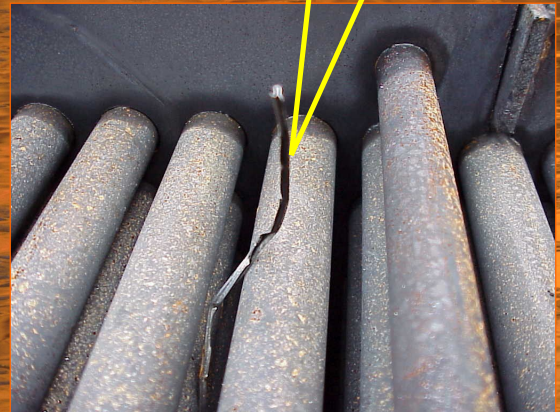
Gasket extending into bundle matrix.

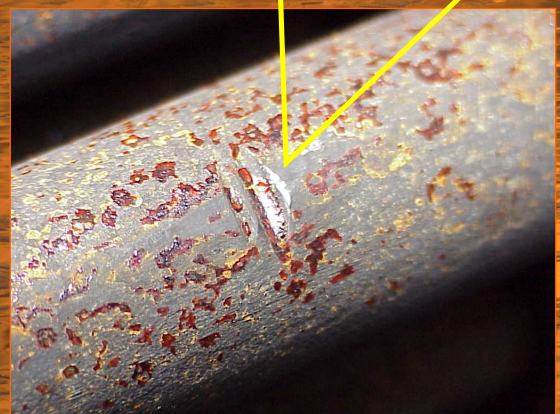
In-situ defect. Note defect contour "V" corresponding with gasket surface contour.

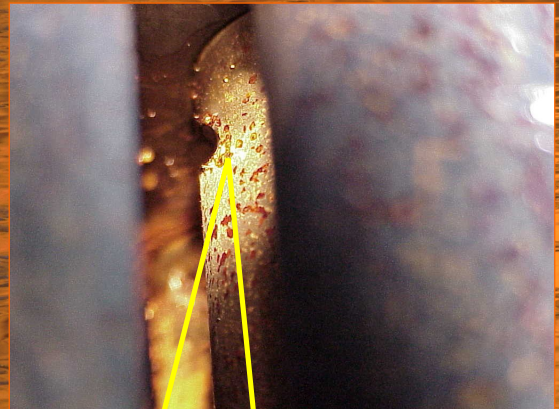
60% depth defect.  
This tube is 2nd row  
down in bundle tube  
matrix.

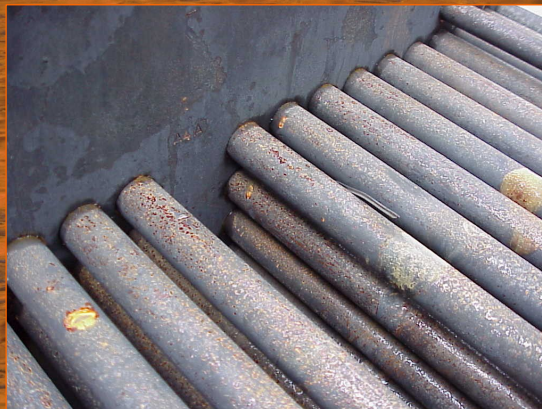
Actual failure.  
Note deep defect.  
Gasket section was  
removed for photo.
