# Magnetec Monthly Chronicle

## What Caused That? Can That Happen?!!!

The exchanger is found in a major Southern Gulf Coast refinery. The bundle was inspected to determine active corrosion mechanism and to aid in life expectancy and service reliability for an expected 5 year operating time frame.

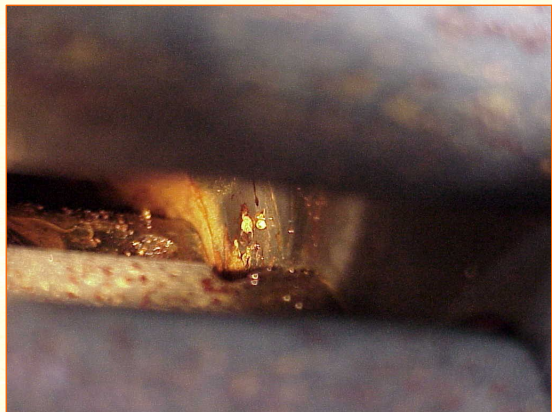
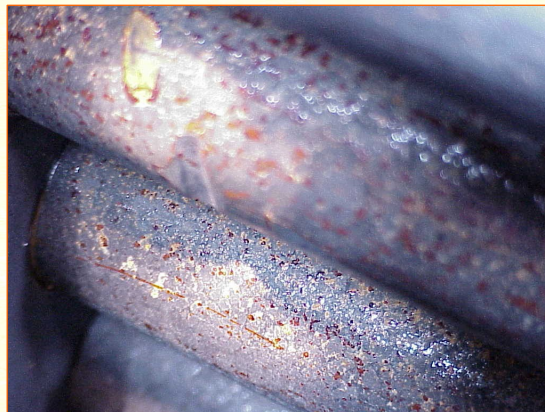
the center shell inlet piping. Based on Video probe visual the failure was a small defect that appeared like a hack saw cut into the tube from the O.D. with full wall penetration. Due to a failed gasket from the channel to shell the bundle was scheduled for pulling which revealed the strange mechanism that caused the failure and adjacent tube damage. Upon pulling of the bundle it was noticed that a stainless spiral-wound gasket had fallen on the top of the tube matrix at the center inlet deflection plate. The gasket was disintegrated with individual windings being spread across the top row of tubes and extending down into the bundle matrix. These single spiral windings had rubbed/fretted the tubing with many very deep defects and caused the thru wall failure. The high shell side flow and sharp side of the stainless gasket winding had cut the tube like a hack saw blade. Based on the amount and location of the gasket pieces found in the tube matrix a 100% inspection of the top 5 rows of tubes was performed and all gasket pieces were removed from the bundle matrix. All tubes with defects

were plugged to returning bundle to service. There was no indication of how the gasket got to its position as the original inlet piping gasket was intact.

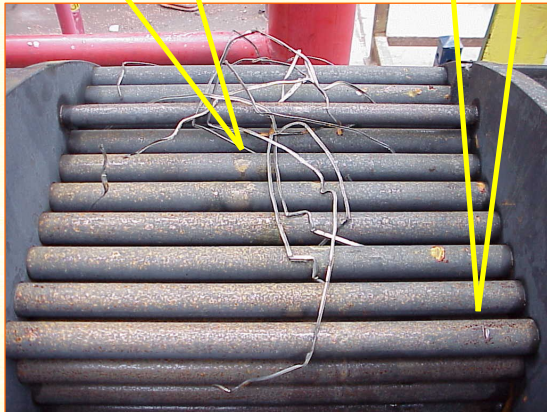
Spiral-wound gasket. As found when bundle was pulled.

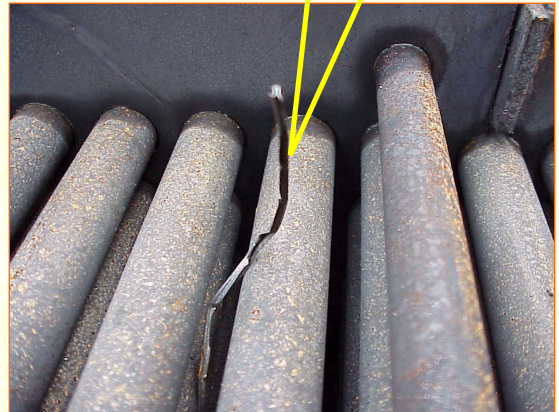
Note Defects.

Gasket extending into bundle matrix.

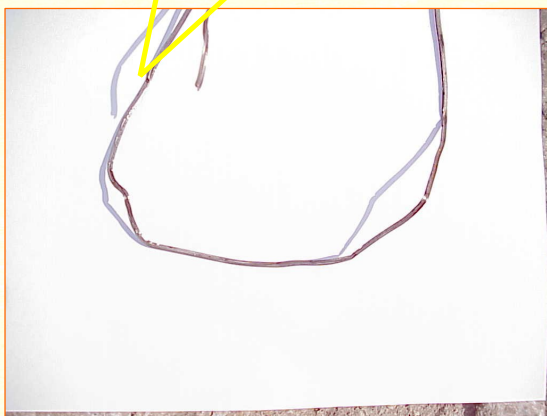
Removed Gasket Section

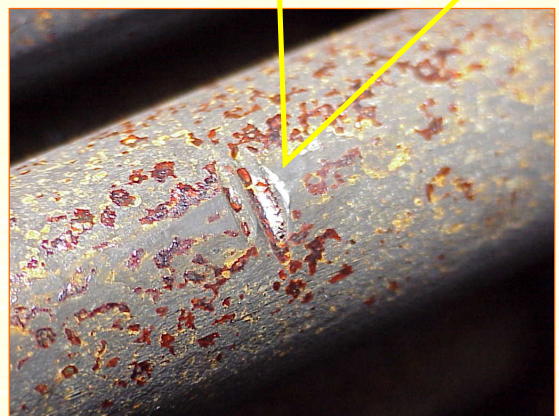
In-situ defect. Note defect contour "V" corresponding with gasket surface contour.

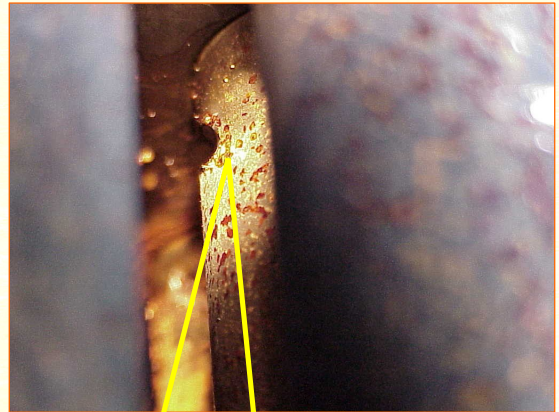
60% depth defect.  
This tube is 2nd row  
down in bundle tube  
matrix.

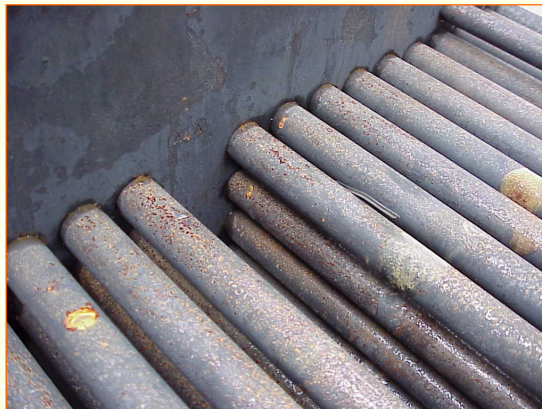
Actual failure.  
Note deep defect.  
Gasket section was  
removed for photo.
