Magnetec Monthly Chronicle

Acid attack/corrosion in Sulfuric Alky unit

The exchanger is found in a medium sized Mid-East refinery. The bundle was inspected to determine active corrosion mechanism and to aid in life expectancy and service reliability for an expected 3 year operating time frame.

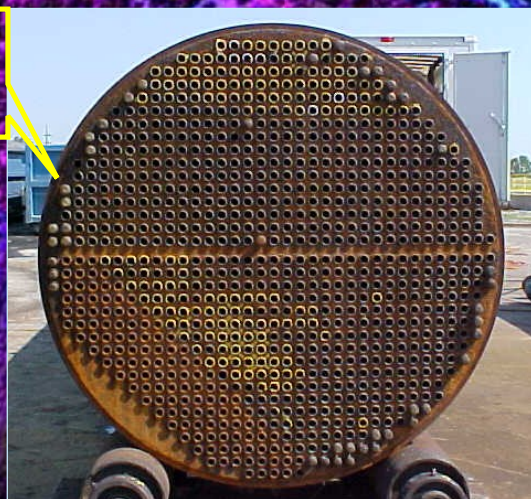
Previous failures (44)

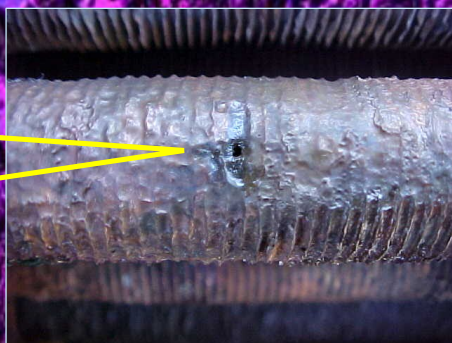
Active failure found during inspection process

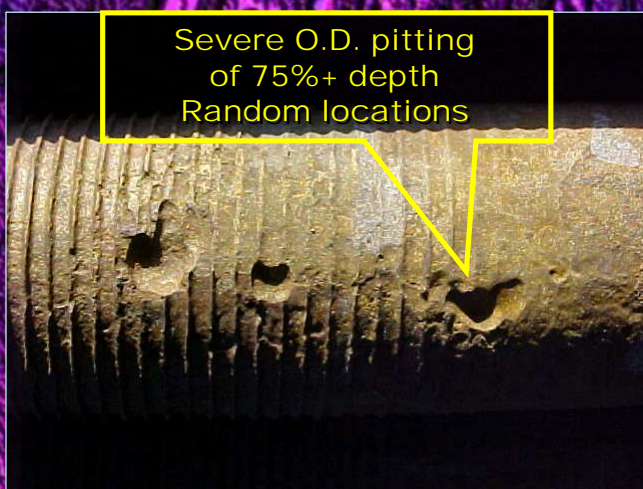
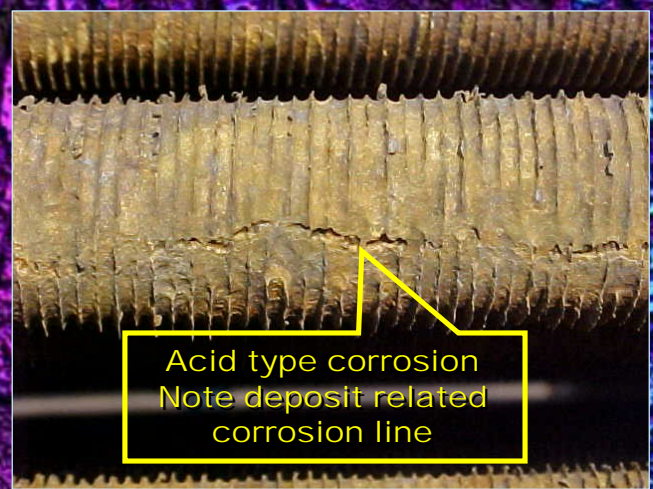
The inspection scheme was performed on 100% of the tubing across the entire bundle matrix with the bundle being previously hydro-blasted and located on the bundle pad. The brass tubing was found to contain O.D. wall loss in the form of severe wastage and isolated pitting across the bundle matrix.

Many detected failures were found across the bundle matrix in random locations along the tube length. The corrosion wastage and pitting is found in heavy concentrations at the approximate center of the tube length which corresponds to the shell side inlet. The bundle was noted with 44 previous plugs and 183 tubes with wall loss/defects of depths 75%+ and 25 active failures. The I.D. surface of the brass tubing was found with no active corrosion or wall loss greater than 10%. The carbon steel tubing could not be inspected due to heavy build-up of calcium type deposits however past history and visual I.D. pits tend to show an active under deposit cooling water type corrosion pattern. The dual metallurgy found in this exchanger

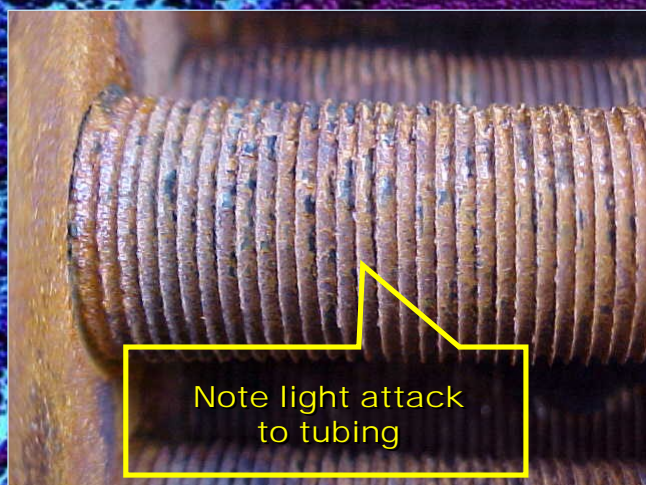
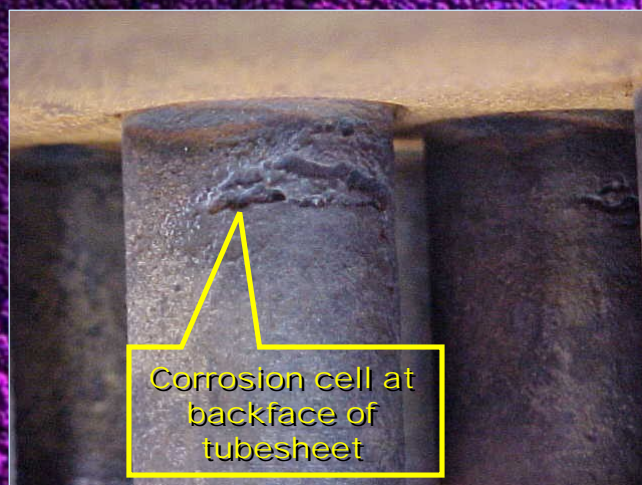
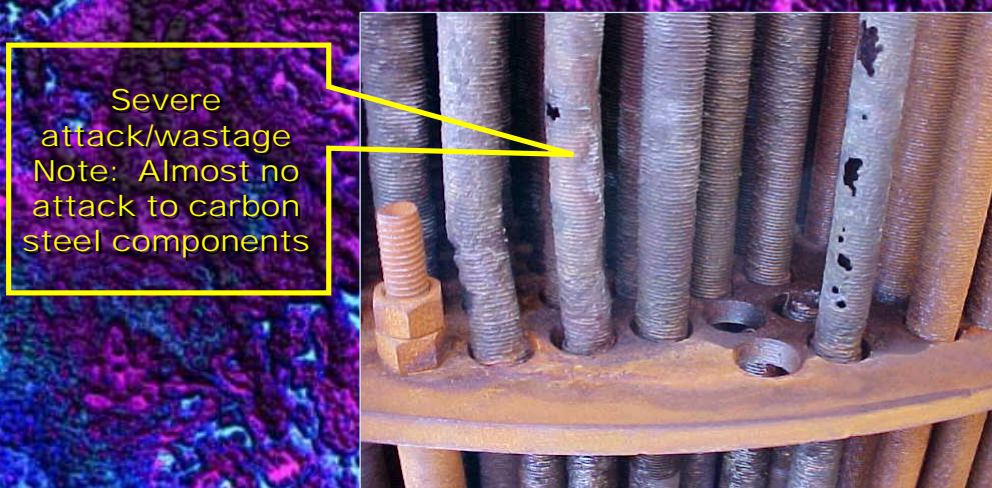
and detected corrosion types tend to show that carbon steel is a good selection for control of shell side acid environment but poor choice for the cooling water service and the brass for poor acid service but good cooling water service. Based on the condition of the tubing and poor resistance of either metallurgies to service conditions the bundle should be replaced with a material upgrade prior to continued service.
