# Magnetec Monthly Chronicle

Issue No.6

June 2005

## Acid attack/corrosion in Sulfuric Alky unit

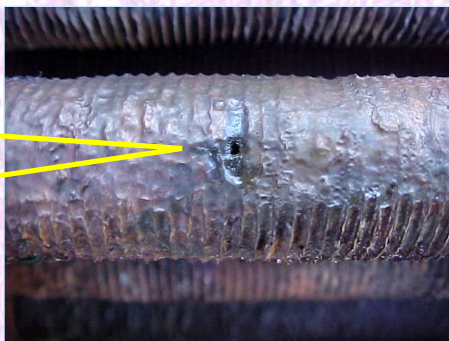
Active failure found during inspection process

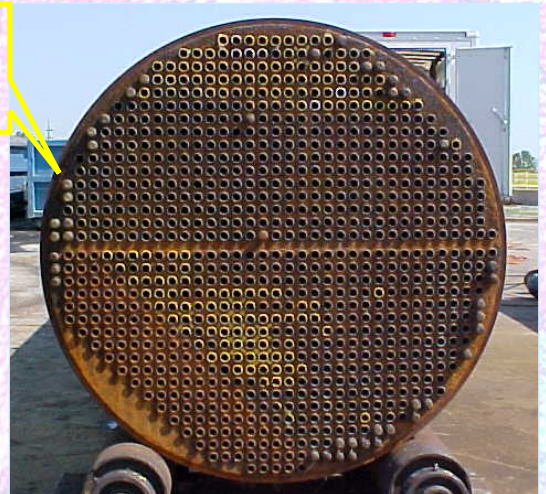
Previous failures (44)

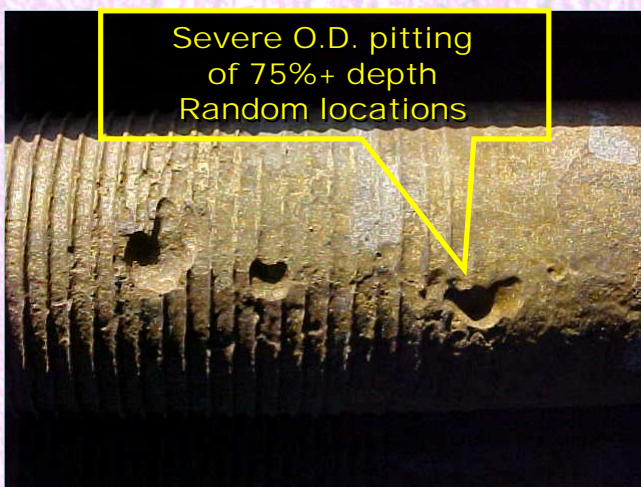
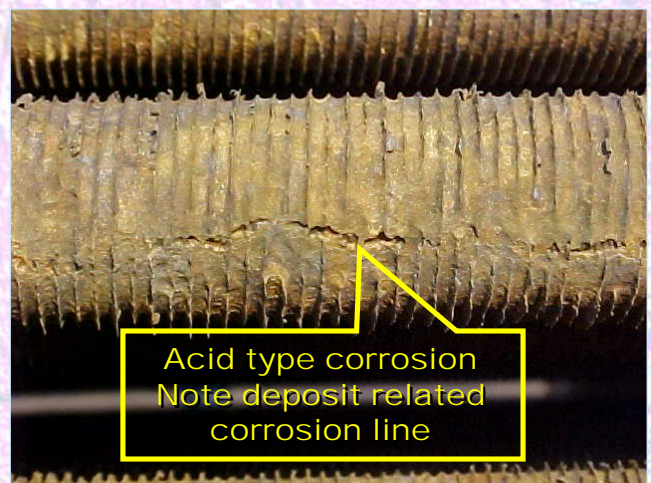
The inspection scheme was performed on 100% of the tubing across the entire bundle matrix with the bundle being previously hydro-blasted and located on the bundle pad. The brass tubing was found to contain O.D. wall loss in the form of severe wastage and isolated pitting across the bundle matrix.

Many detected failures were found across the bundle matrix in random locations along the tube length. The corrosion wastage and pitting is found in heavy concentrations at the approximate center of the tube length which corresponds to the shell side inlet. The bundle was noted with 44 previous plugs and 183 tubes with wall loss/defects of depths 75%+ and 25 active failures. The I.D. surface of the brass tubing was found with no active corrosion or wall loss greater than 10%. The carbon steel tubing could not be inspected due to heavy build-up of calcium type deposits however past history and visual I.D. pits tend to show an active under deposit cooling water type corrosion pattern. The dual metallurgy found in this exchanger

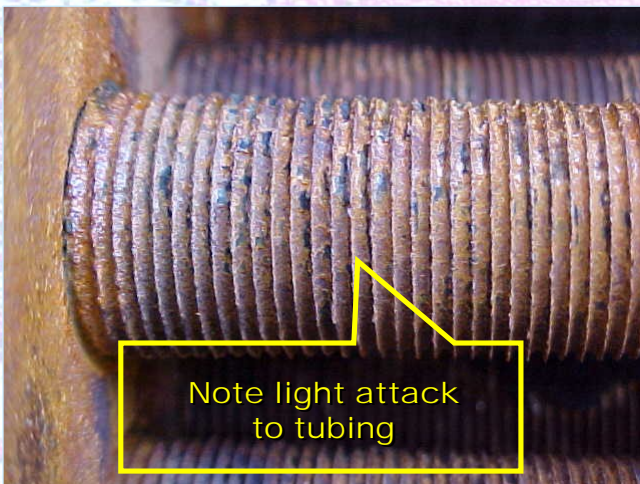
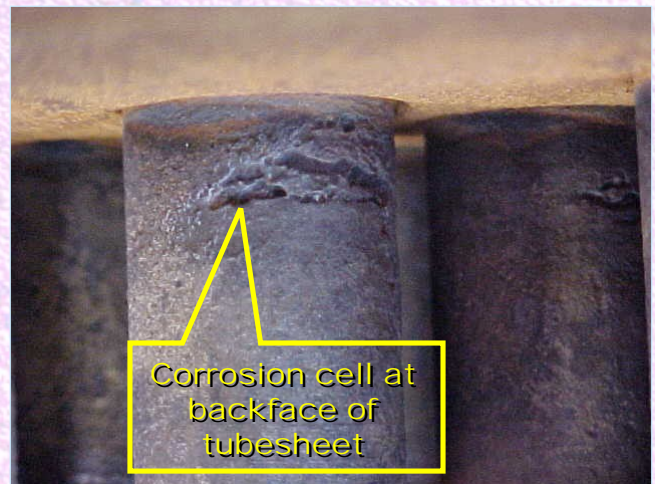
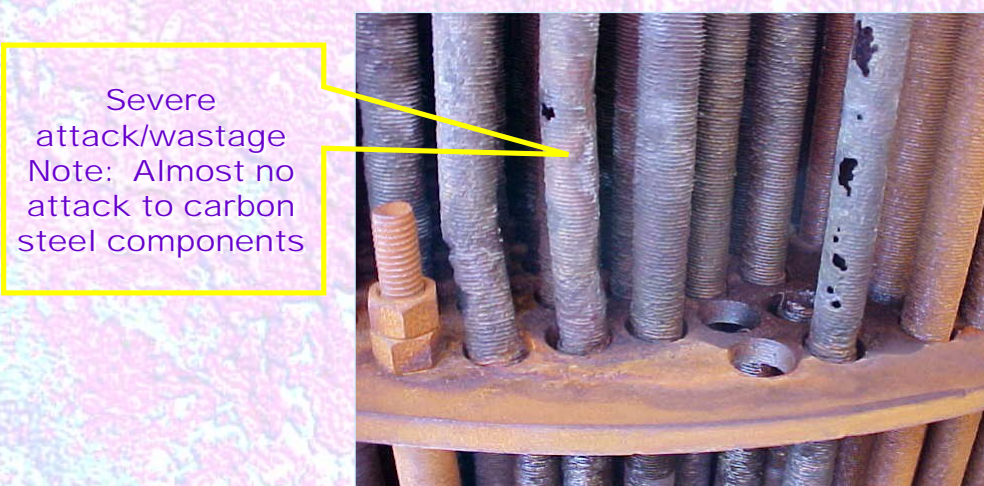
and detected corrosion types tend to show that carbon steel is a good selection for control of shell side acid environment but poor choice for the cooling water service and the brass for poor acid service but good cooling water service. Based on the condition of the tubing and poor resistance of either metallurgies to service conditions the bundle should be replaced with a material upgrade prior to continued service.
