Magnetec Monthly Chronicle

Issue No.7

WOW Only 4 Months of Service!

Subject: Organic acids/salts corrosion in Atmospheric Crude unit

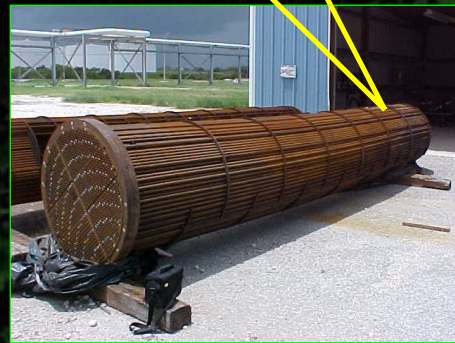
Area of most severe corrosion

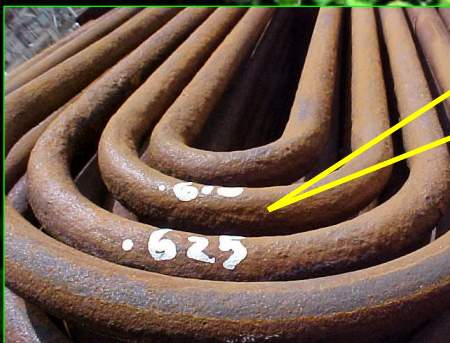
Top half of bundle adjacent to shell side inlet. Note general corrosion to u-bends

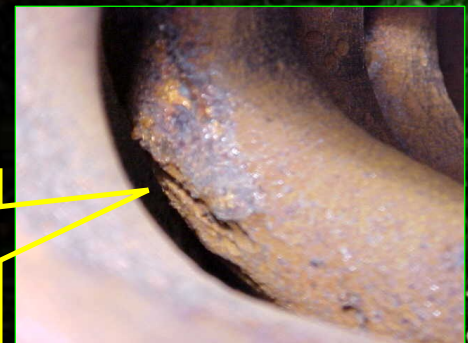
Severe corrosion with depths to 70%. Location is 2nd row into bundle matrix at u-bends

The active corrosion is a combined defect type of single and multiple pit sites within a general corrosion area. The pitting is found in heavy concentrations and inter-connected with adjacent pit sites with depths of 15%-45% in most cases. The general wall loss is noted with the most severe attack on the top half of the bundle near the u-bends with wall loss of 65% at the apex of the bends. The active corrosion mechanism is due to entrained organic acid/salts from the atmospheric OVHD feed laying out on the tube wall and establishing an aggressive corrosion environment. The shell side inlet is found at the top rear of the bundle where process gas enters the bundle matrix and courses through the single segmented baffles towards the

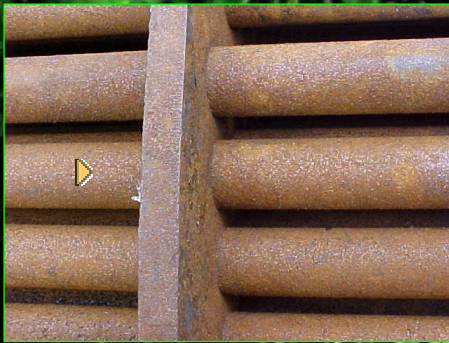
Tube and support condition away from corrosion zone

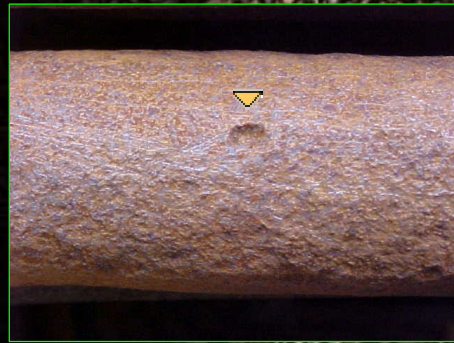
Isolated deep pitting

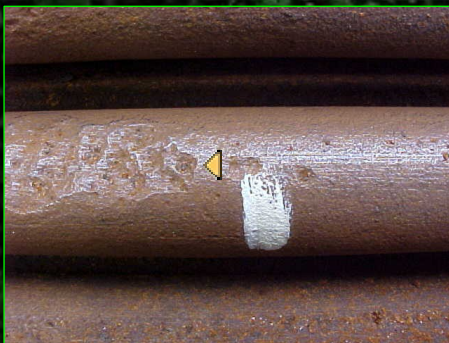
Isolated and interconnected pit sites

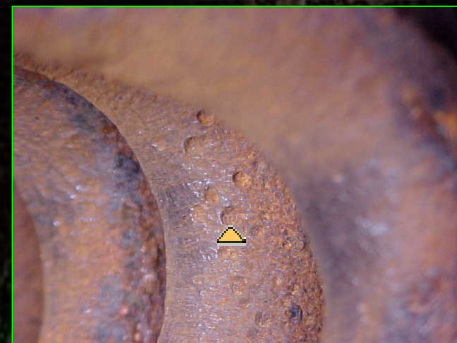
Pitting at u-bends, 40% depth

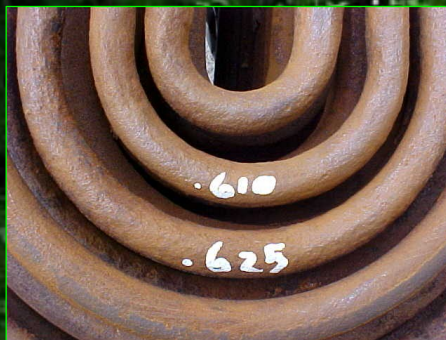
View of top periphery u-bends adjacent to inlet piping
