Magnetec Monthly Chronicle

Issue No.7

WOW Only 4 Months of Service!

Subject: Organic acids/salts corrosion in Atmospheric Crude unit.

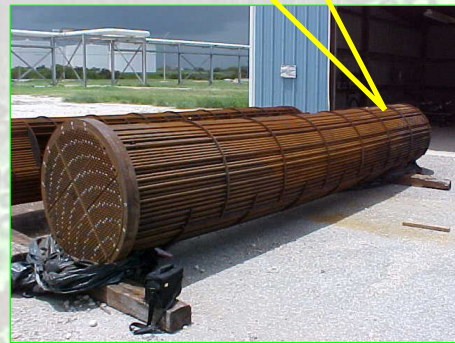
Area of most
severe
corrosion

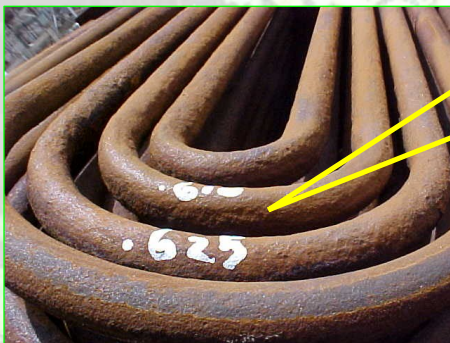
Top half of bundle adjacent to shell side inlet. Note general corrosion to u-bends

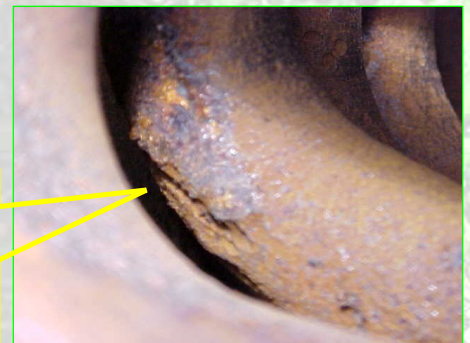
Severe corrosion with depths to 70%. Location is 2nd row into bundle matrix at u-bends

The active corrosion is a combined defect type of single and multiple pit sites within a general corrosion area. The pitting is found in heavy concentrations and inter-connected with adjacent pit sites with depths of 15%-45% in most cases. The general wall loss is noted with the most severe attack on the top half of the bundle near the u-bends with wall loss of 65% at the apex of the bends. The active corrosion mechanism is due to entrained organic acid/salts from the atmospheric OVHD feed laying out on the tube wall and establishing an aggressive corrosion environment. The shell side inlet is found at the top rear of the bundle where process gas enters the bundle matrix and courses through the single segmented baffles towards the

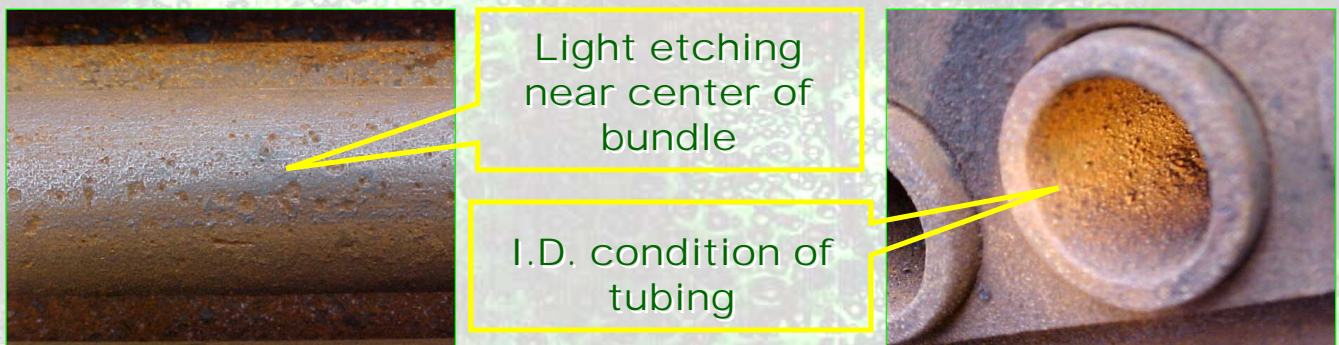
front of the bundle. It is the first 1/3 of the process gas path that the most lay-out of corrosion constituents occurs and the associated heavy corrosion is noted. The corrosion tends to taper and diminish in attack as the process gas works from the back of the bundle to the front outlet.

The past history for this exchanger service has many in-service failures and replacement bundles with service cycles as low as 4 months when 1st tube failure was noted. The history and past Eddy Current inspection has documented the active corrosion mechanism and location which could be controlled by a material upgrade resistant to the corrosion constituents within the process gas. Due to relative young age of the bundle and the severe O.D. corrosion detected the bundle is considered in poor service condition and was retubed with a material upgrade.

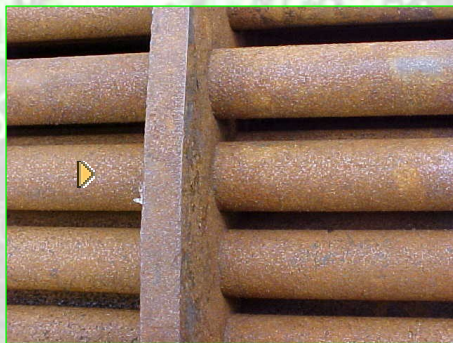
Tube and support condition away from corrosion zone

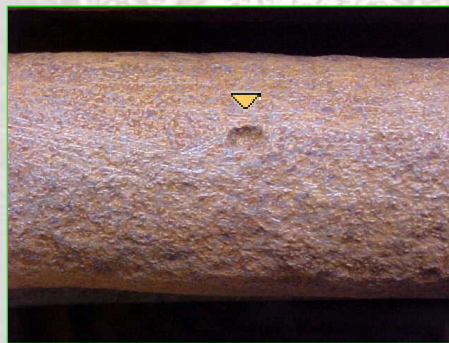
Isolated deep pitting

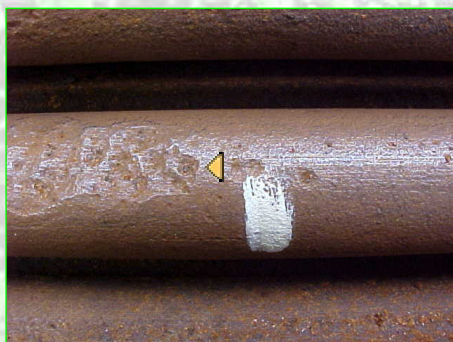
Isolated and interconnected pit sites

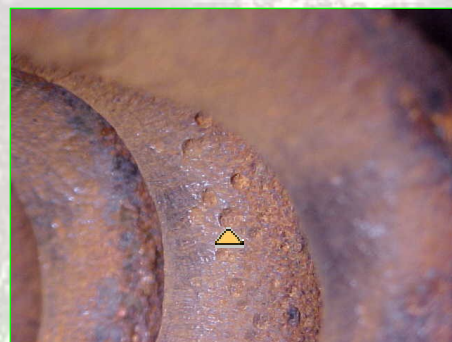
Pitting at u-bends, 40% depth

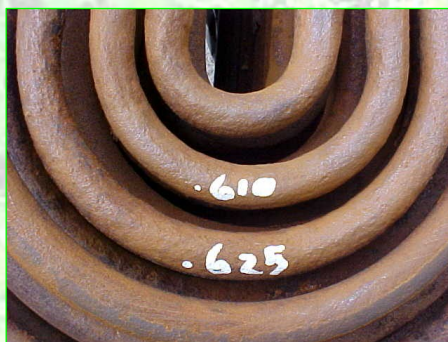
View of top periphery u-bends adjacent to inlet piping
