Magnetec Monthly Chronicle

Issue No.9 " FROM THE FIELD " September 2005

The Finfan Exchanger is Found in a Major Mid-western Refinery

Subject: Corrosion Protection by Sleeve Installation

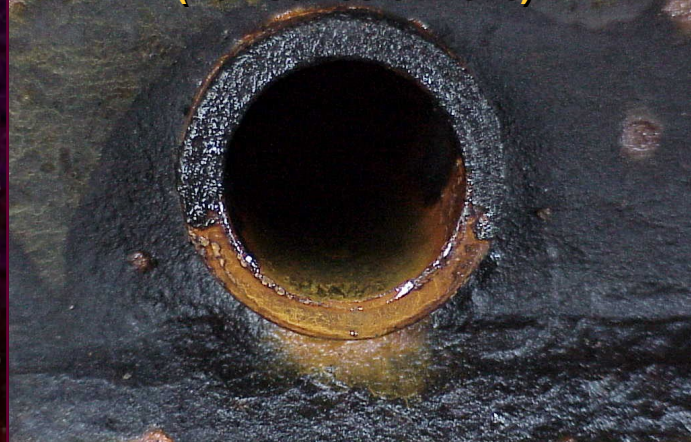
**Original thickness tube in outlet pass
(non-corrosion zone)**

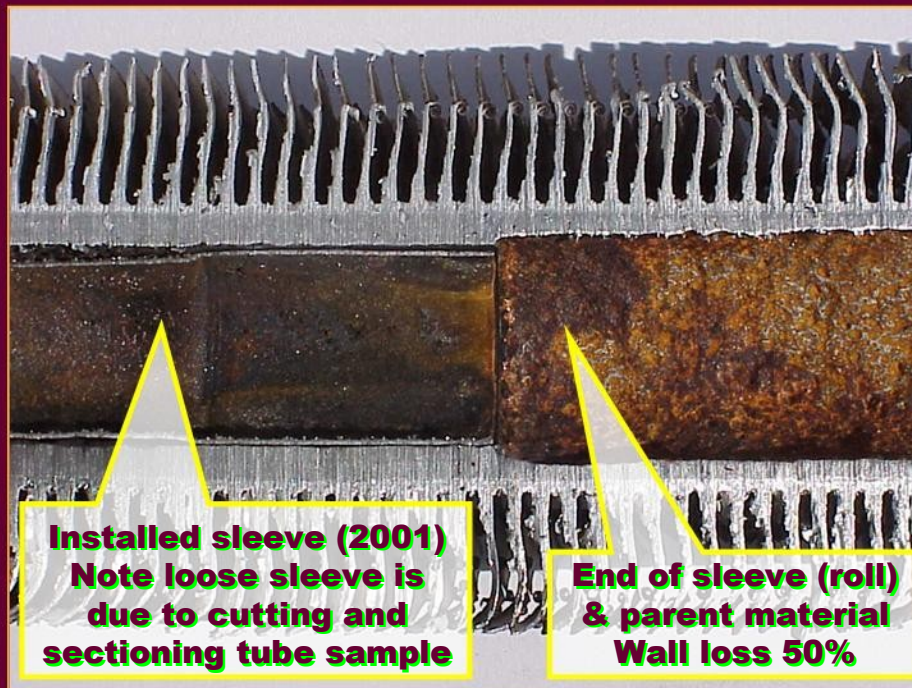
Pulled tube sample – Location at Sleeve/tube interface
