# Magnetec Monthly Chronicle

Issue No.9  
September 2005

## The Finfan Exchanger is Found in a Major Mid-western Refinery

**Subject: Corrosion Protection by Sleeve Installation**

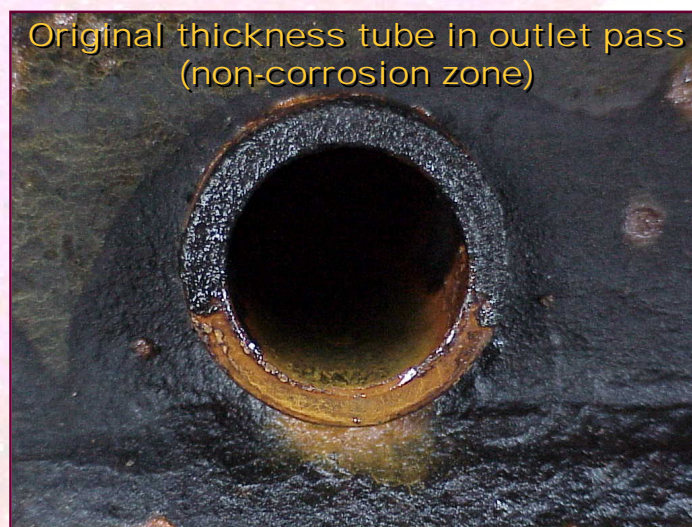
found the crude slates to be considerably more sour and corrosion additive (filming agents) rates at about ½ normal rates due to clogged injection quills. The corrosion rate and extension down the tube length would be somewhat normal based on the significant changes in the operating conditions. During the inspection process 2 tubes in the most severely corroded areas were pulled to document the corrosion mechanism, extent of attack, and to determine if re-sleeving to an extended length was possible. The attached photos are representative of the pulled tube sample and show the parent tube material protected by the sleeve and the corrosion extent in the unprotected tube length. It was determined that the finfan could be re-sleeved with 10' foot sleeves to protect the tubing beyond the new corrosion zone. On average, the finfan banks had an expected life of 5 years prior to the first failure which was extended to 7 years prior to the first failure with the addition of protective sleeves. The changes in the operating conditions were a prime mitigating factor in the advancement of the corrosion down the tube length.

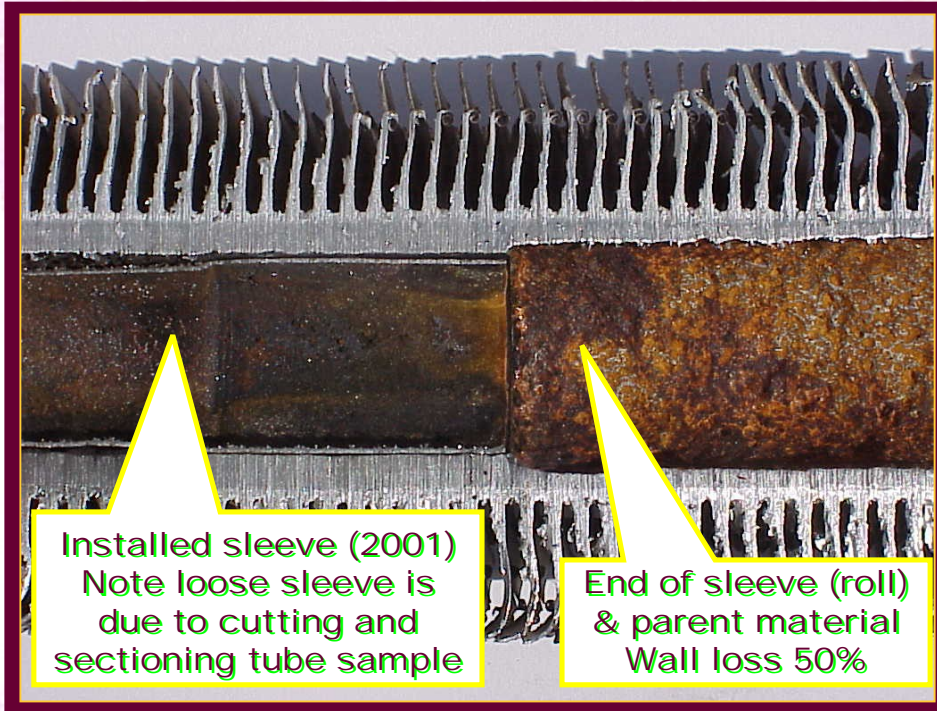
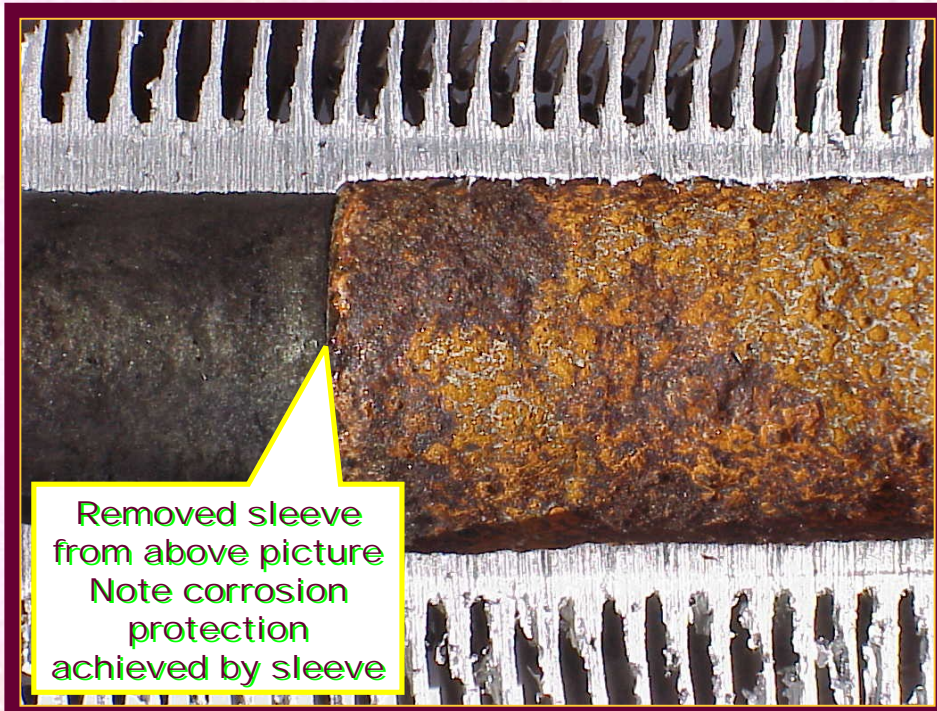
Pulled tube sample – Location at Sleeve/tube interface
