Magnetec Monthly Chronicle

Issue No.10 " FROM THE FIELD " October 2005

Is it Stress Corrosion, Corrosion Fatigue, or Hydrogen Induced?

Subject: Cracking

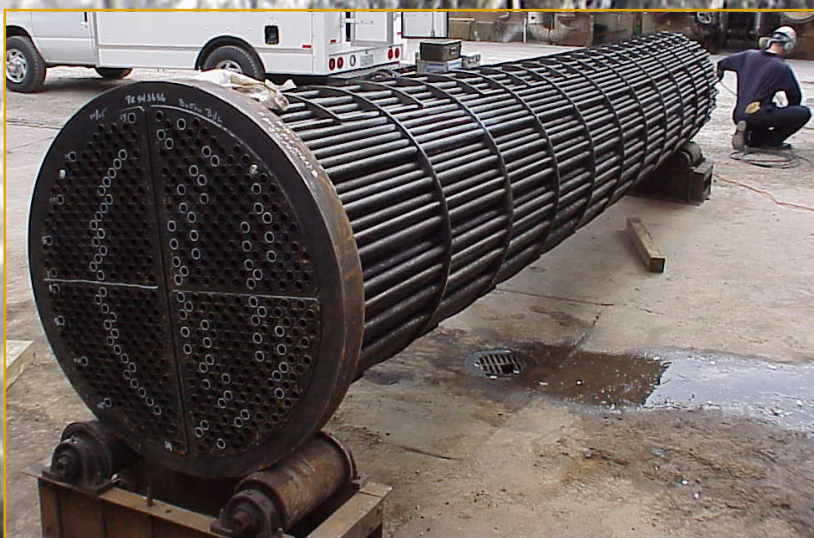
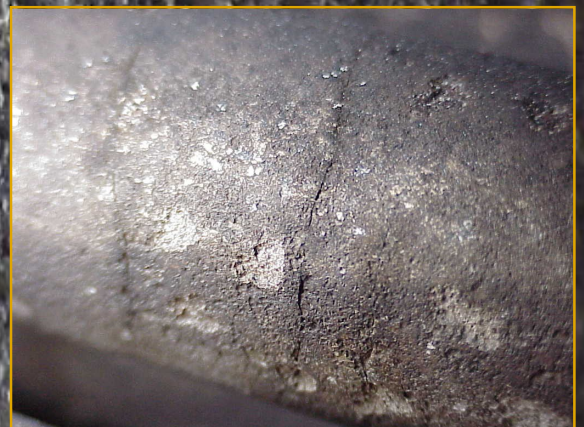
type mechanisms, in medium temperature chloride environments. The RFET inspection was performed on 100% of the tubing to determine the presence of the cracking mechanism and determine the defect depths and remaining life of the bundle. The inspection found cracks with depths from initiation to 55% in the upper bundle and 45% in the lower bundle. The cracking was most pronounced near the rear of the upper bundle which is adjacent to the rear shell side inlet feed to both bundles and corresponds to the highest heat area for the counter current process flows. The lower bundle experienced cracking to a lesser degree with the cracking near the front of the bundle near/adjacent to the front shell side inlet. The bundle was reported with very heavy shell side fouling after being pulled which would retard the heat transfer across the tube wall and allow for high heat gradients within the tube wall.

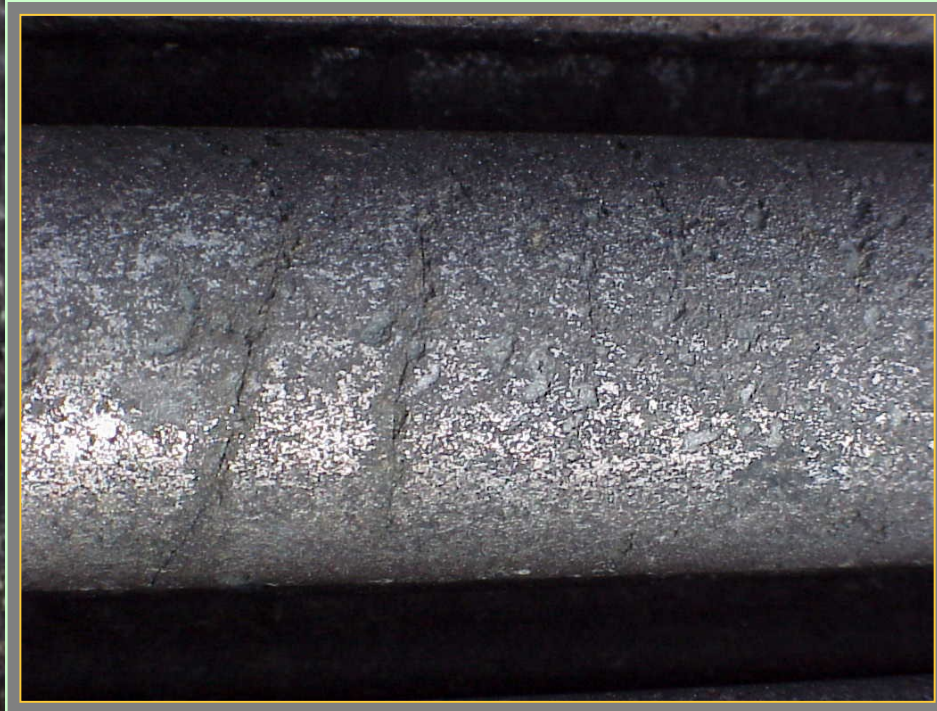
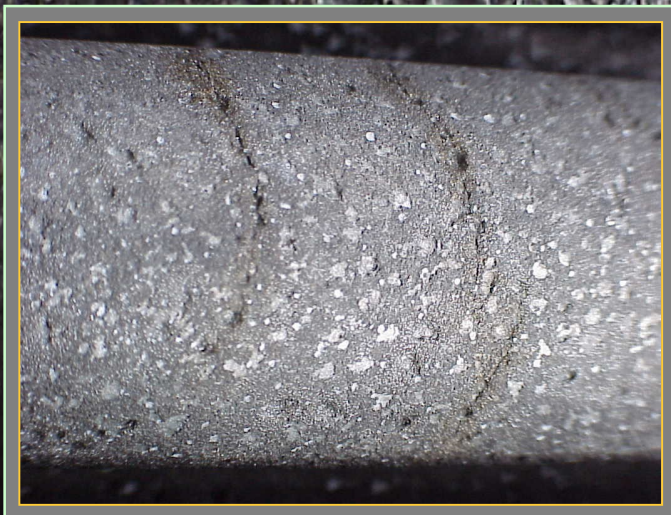
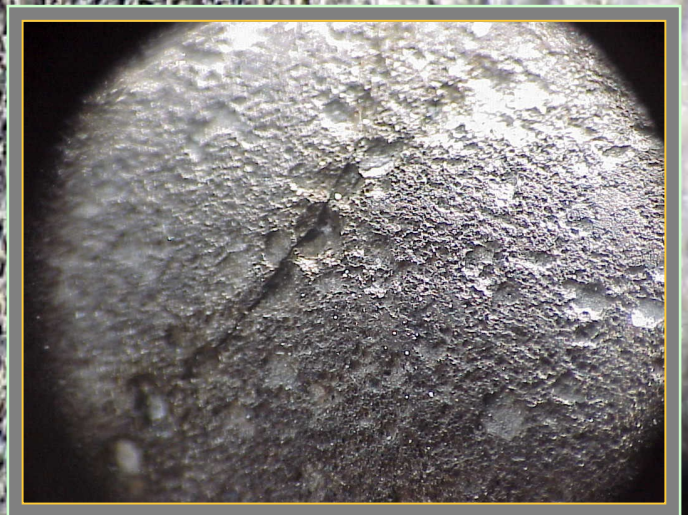
Based on the location of the cracks, crack pattern, concentration and depth, the cracking mechanism appeared to be related to a flow process across the bundle matrix which alludes to either a corrosion/chemical attack, or a heat related phenomena, or a combination of both. The cracks appeared to be consistent in their spacing and relative crack depths as the process flows passed through their specific bundles which is indicative of the driving event diminishing across the bundle length and therefore is believed to be related to temperature gradients. The process is in the mid range of the recommended operating temperatures for the 2205 material and well below the 600 degree operating limit specified by the manufacturer and the ASME (885 ferrite embrittlement). The post bending stress relieved U-bends were noted with no cracking type mechanism in either bun-

dle which tends to indicate a heat treatment condition (straight section) from the manufacturer that is susceptible to the cracking mechanism. The inter-relationship of corrosion fatigue, stress corrosion and hydrogen embrittlement cracking mechanisms, and the wide spectrum of conditions, both in material environment, and metallurgical states, generally overlap and can be a combination of any and/or all the phenomena. There tends to be a central initiating factor that encompasses all three of the individual mechanisms and crack initiation to ultimate failure might be classified to any of the separate mechanisms as the crack progress's through stages. It should be noted that the bundles in question might have experienced a single event or limited number event cycle that initiated the crack sequence, & crack propagation has since ceased. This condition could only be determined by metallographic tests of the material and crack face for telltale signs of re-passivation or continued crack growth. The bundles were detected with O.D. pitting with depths of 15%-35% along the tube length and across the entire bundle matrix, however, this mechanism was not considered a service related problem. Cracks most probably initiated at the pit locations. Based on the age of the bundle, defect depths, and economic loss's due to re-occurring failures, both bundles were retubed.
