Magnetec Monthly Chronicle

Issue No.10 " FROM THE FIELD " October 2005

Is it Stress Corrosion, Corrosion Fatigue, or Hydrogen Induced?

Subject: Cracking

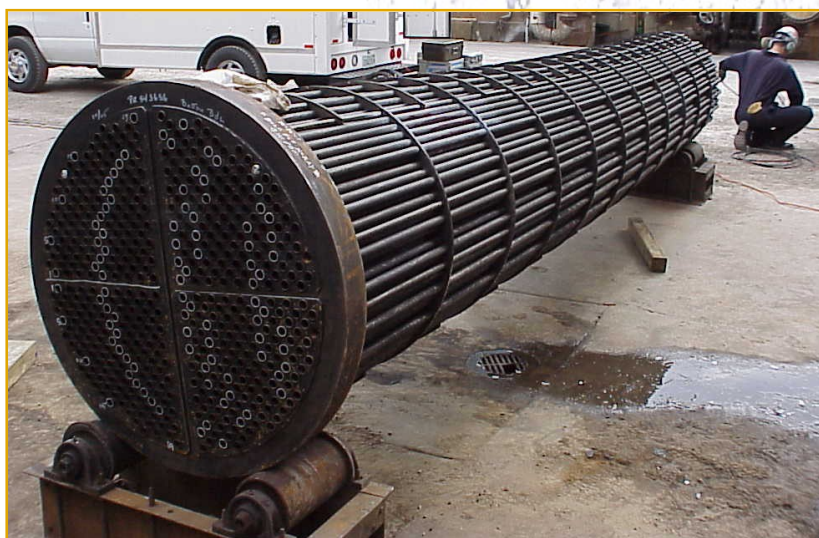
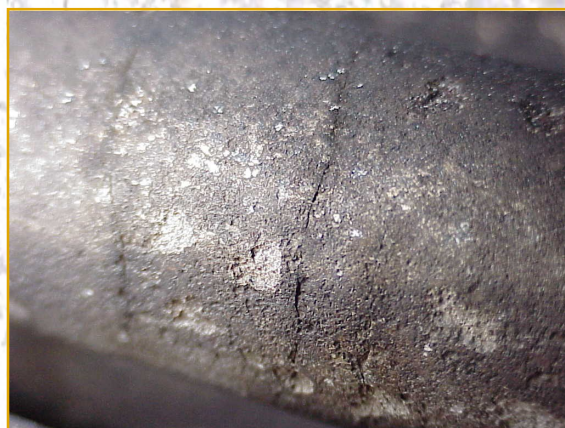
type mechanisms, in medium temperature chloride environments. The RFET inspection was performed on 100% of the tubing to determine the presence of the cracking mechanism and determine the defect depths and remaining life of the bundle. The inspection found cracks with depths from initiation to 55% in the upper bundle and 45% in the lower bundle. The cracking was most pronounced near the rear of the upper bundle which is adjacent to the rear shell side inlet feed to both bundles and corresponds to the highest heat area for the counter current process flows. The lower bundle experienced cracking to a lesser degree with the cracking near the front of the bundle near/adjacent to the front shell side inlet. The bundle was reported with very heavy shell side fouling after being pulled which would retard the heat transfer across the tube wall and allow for high heat gradients within the tube wall.

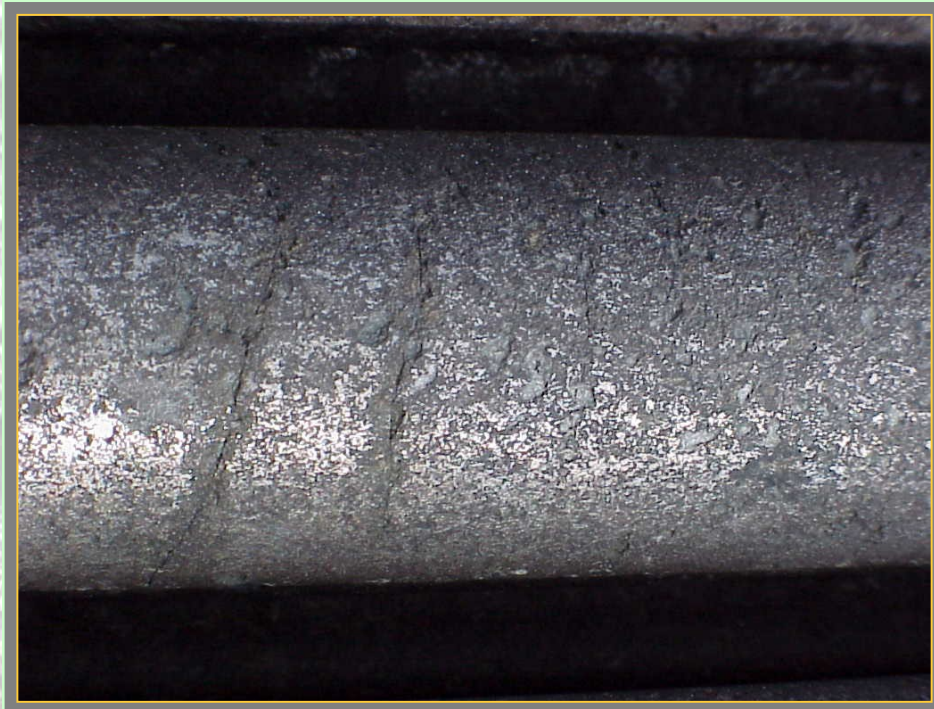
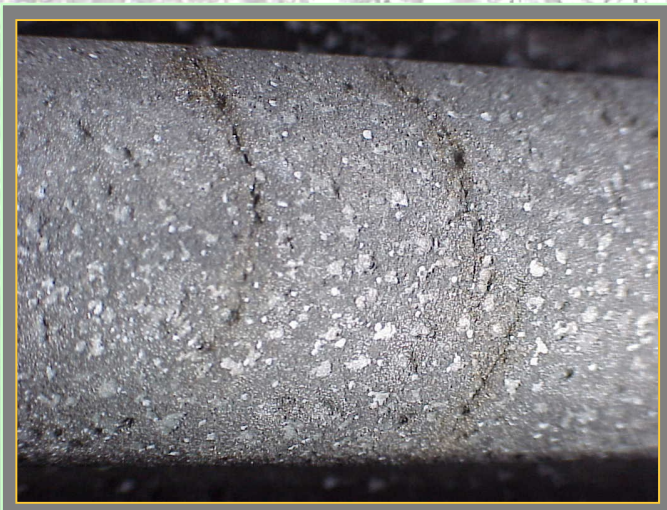
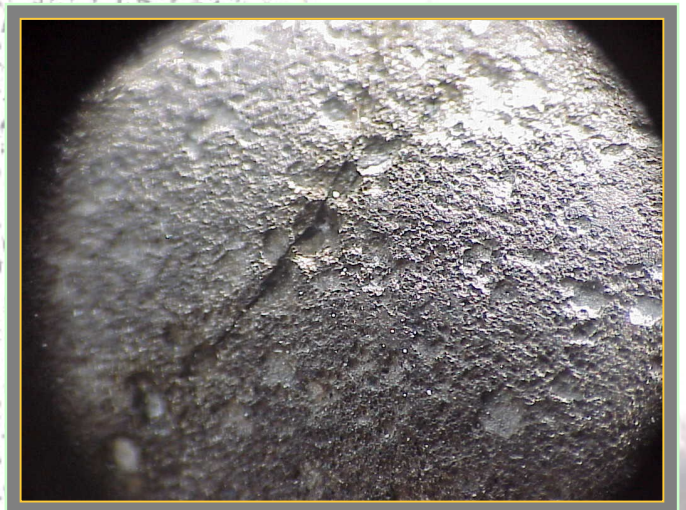
Based on the location of the cracks, crack pattern, concentration and depth, the cracking mechanism appeared to be related to a flow process across the bundle matrix which alludes to either a corrosion/chemical attack, or a heat related phenomena, or a combination of both. The cracks appeared to be consistent in their spacing and relative crack depths as the process flows passed through their specific bundles which is indicative of the driving event diminishing across the bundle length and therefore is believed to be related to temperature gradients. The process is in the mid range of the recommended operating temperatures for the 2205 material and well below the 600 degree operating limit specified by the manufacturer and the ASME (885 ferrite embrittlement). The post bending stress relieved U-bends were noted with no cracking type mechanism in either bundle which tends to indicate a heat

treatment condition (straight section) from the manufacturer that is susceptible to the cracking mechanism. The inter-relationship of corrosion fatigue, stress corrosion and hydrogen embrittlement cracking mechanisms, and the wide spectrum of conditions, both in material environment, and metallurgical states, generally overlap and can be a combination of any and/or all the phenomena. There tends to be a central initiating factor that encompasses all three of the individual mechanisms and crack initiation to ultimate failure might be classified to any of the separate mechanisms as the crack progress's through stages. It should be noted that the bundles in question might have experienced a single event or limited number event cycle that initiated the crack sequence, and crack propagation has since ceased. This condition could only be determined by metallographic tests of the material and crack face for telltale signs of re-passivation or continued crack growth. The bundles were detected with O.D. pitting with depths of 15%-35% along the tube length and across the entire bundle matrix, however, this mechanism was not considered a service related problem. Cracks most probably initiated at the pit locations. Based on the age of the bundle, defect depths, and economic loss's due to re-occurring failures, both bundles were retubed.

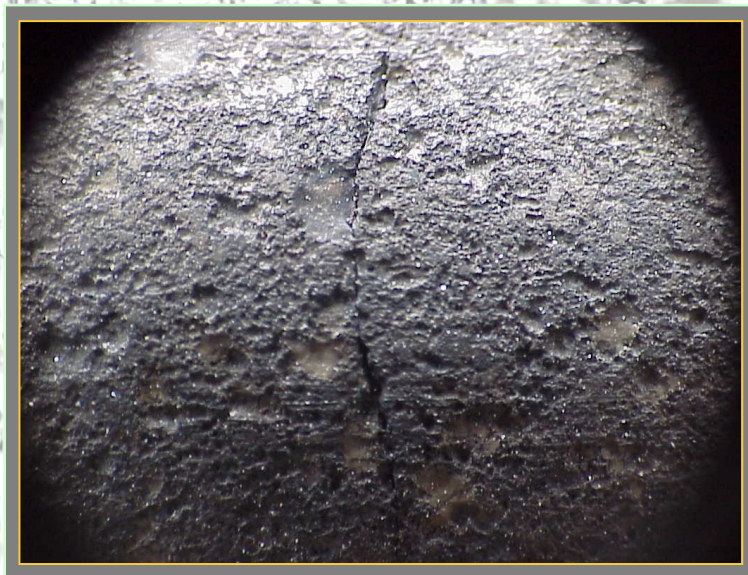
Note axial crack propagation from circ. crack
