# Magnetec Monthly Chronicle

Issue No.13 " FROM THE FIELD " March 2006

**Subject: Pitting in Brass Crude Overhead Condenser**

**Low Heat Levels for Long Periods of Time  
Have the Same Net Effect as  
High Heat Levels for Short Time Frames**

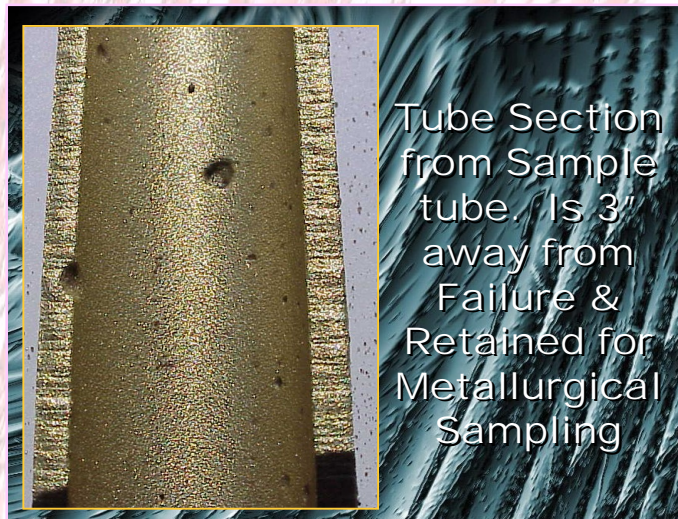
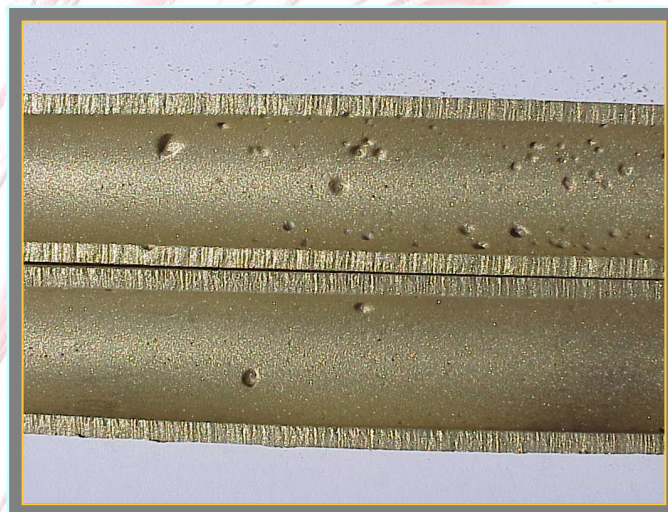
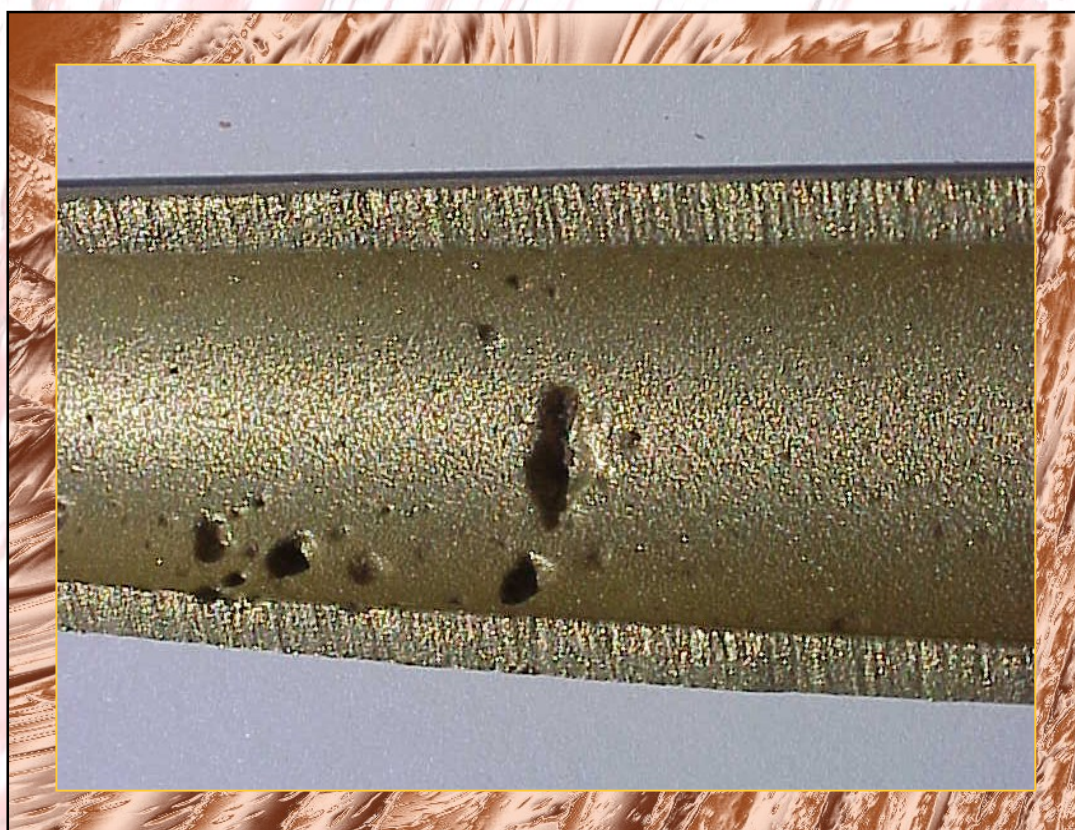
inexperienced technicians, the results can be defects which are reported incorrectly. Brass tubing will tend to de-alloy (De-zincification) in high heat gradient areas and pit sites will develop due to the disruption of the alloy structure and elemental copper released from the parent material will lay-out in the pit sites which is commonly called plug type de-zincification. Material in this de-alloy and pitted condition is highly susceptible to failure from pit penetration and /or cracking. Tube samples were removed from the bundle to document the active corrosion mechanisms and allow for material to be sent out for metallurgical analysis. The inter-relationship of selective de-alloy and subsequent pitting is rather common in brass tubing and bundles in this service. There tends to be a central initiating factor that encompasses the de-alloy and pitting sequence which is high heat gradients, fouling/deposition of contaminants, and many years of established corrosion cell environment. For the purpose of this discussion, the term "high heat gradient" is referring to heat levels at and/or below the recommended operating temperature for brass tubing. Low heat levels for long periods of time have the same net effect as high heat levels for short time frames. Based on the age of the bundle, defect depths and economic loss's due to re-occurring failures both bundles were re-tubed.
