Issue No.14

April 2006

Magnetec Inspection, Inc.

Subject: Localized Over Heat & Associated Failures in Stainless Steel Pipe

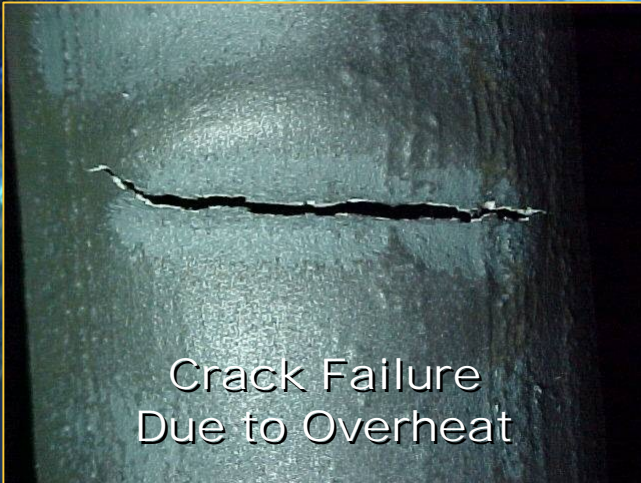
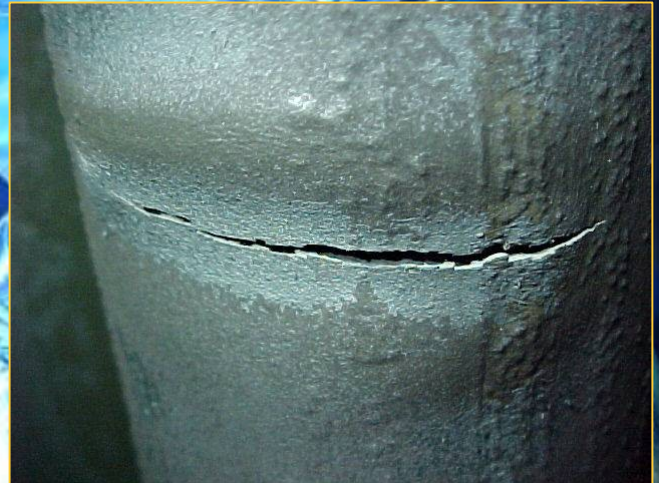
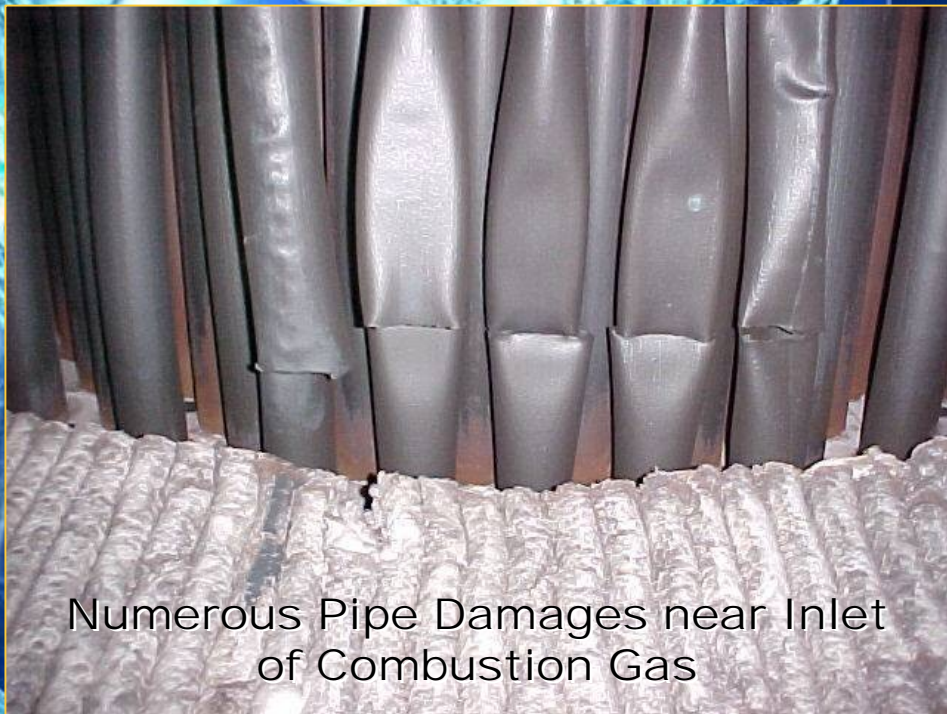
An inspection of the Air Heater piping showed severe distortion (buckling), discoloration & scaling. A pipe section was seen to have an extensive circumferential crack. The Air pipes were observed with light discoloration which indicative of an overheat condition.

contained mechanical damages from buckling and crimping which correlates to the high heat flux zones and is consistent with material actions in overheat conditions. There were pipes with cracks which is also a secondary failure mode associated with the primary overheat condition. Overheat damage can be associated with low heat over long time frames, high heat over short time frames and high heat flux differentials which can occur with fast heat-up or cool down scenarios. The damage noted could have been from a single event or most likely a combination of the separate heat conditions.

Buckled Tube with Associated Failure

It would appear that the operating temperature of the stainless steel pipe had been in excess of the recommended limits which resulted in extensive distortion taking place and caused/accelerated grain boundary disruptions and distortions, which greatly reduces the life of the steel.

Temperature probes on the pipe during operation would ensure that the maximum acceptable temperature is not exceeded. This would have prevented the damage from the high heat flux differential that is now evident in the existing pipe.

Pipe samples were removed from the bundle to document the active failure mechanisms and allow for material to be sent out for metallurgical analysis. The inter-relationship of susceptible materials and high heat flux's tend to be a central initiating factor that encompasses the recent failures. Based on the age of the air heater piping, significant overheat damage and economic losses due to food and equipment contamination the heaters were re-piped.
