Issue No.14

April 2006

Overheating & Cooling

Subject: Localized Over Heat & Associated Failures in Stainless Steel Pipe

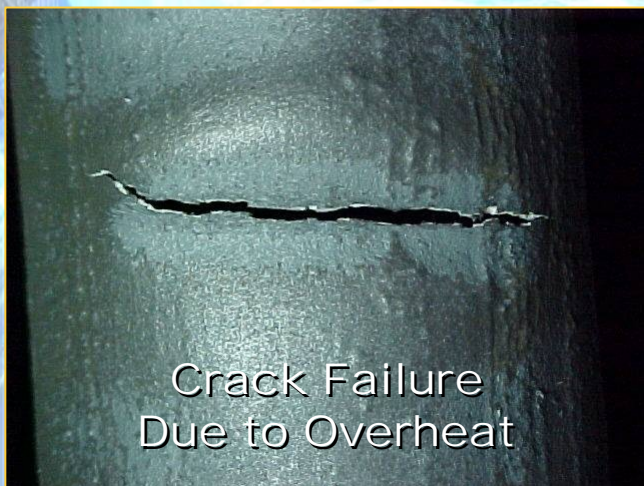
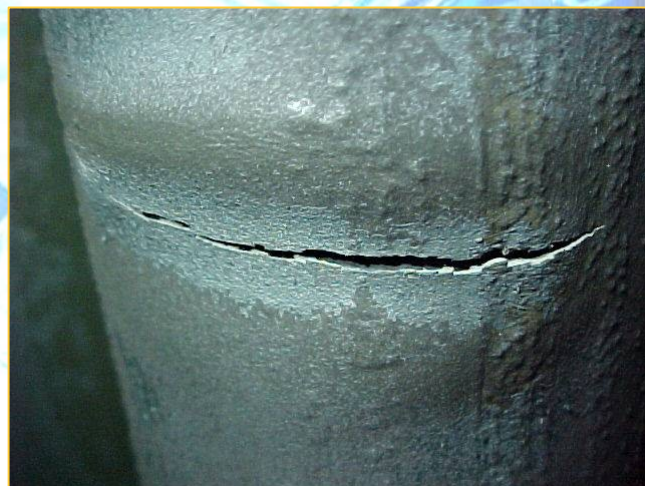
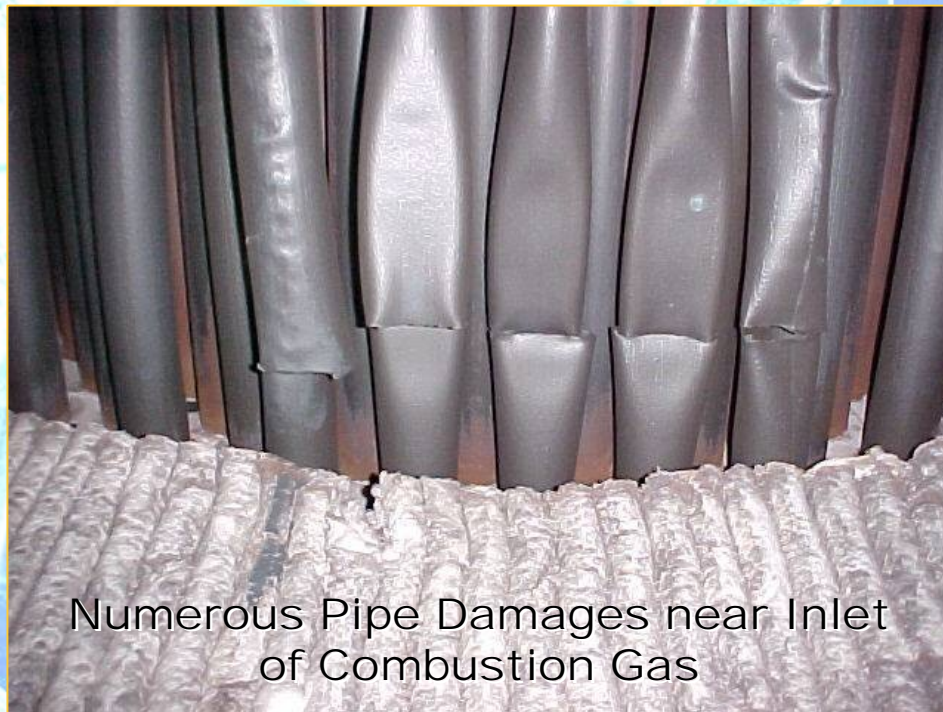
An inspection of the Air Heater piping showed severe distortion (buckling), discoloration & scaling. A pipe section was seen to have an extensive circumferential crack. The Air pipes were observed with light discoloration which indicative of an overheat condition.

contained mechanical damages from buckling and crimping which correlates to the high heat flux zones and is consistent with material actions in overheat conditions. There were pipes with cracks which is also a secondary failure mode associated with the primary overheat condition. Overheat damage can be associated with low heat over long time frames, high heat over short time frames and high heat flux differentials which can occur with fast heat-up or cool down scenarios. The damage noted could have been from a single event or most likely a combination of the separate heat conditions.
