# Magnetec Monthly Chronicle

Issue No.5

May 2005

## What Caused That? Can That Happen?!!!

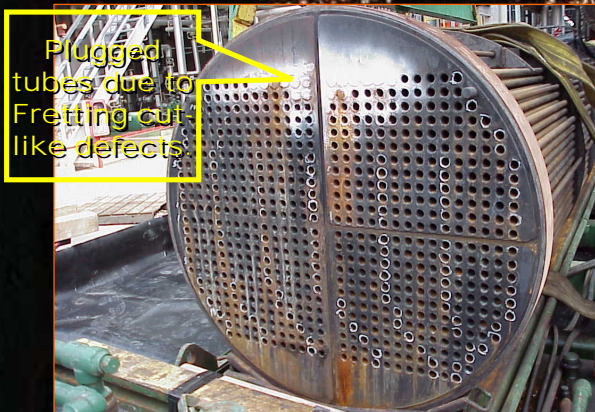
The exchanger operates with a sister/parallel as MSTDP process Column Reboiler. The tubing consists of XXX U-tubes – 1" X .109 min wall X SA-213 T11 X 20 Foot long. The exchanger was reported with 1 possible failure prior to shutdown.

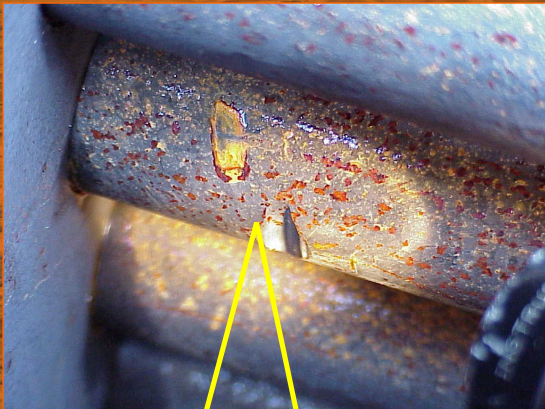
60% depth defect.  
This tube is 2nd row  
down in bundle tube  
matrix.
