# Magnetec Monthly Chronicle

## What Caused That? Can That Happen?!!!

The exchanger is found in a major Southern Gulf Coast refinery. The bundle was inspected to determine active corrosion mechanism and to aid in life expectancy and service reliability for an expected 5 year operating time frame.

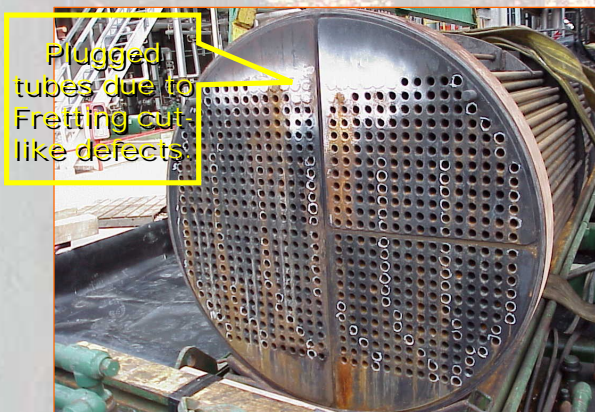
The exchanger operates with a sister/parallel as MSTDP process Column Reboiler. The tubing consists of XXX U-tubes – 1" X .109 min wall X SA-213 T11 X 20 Foot long. The exchanger was reported with 1 possible failure prior to shutdown.

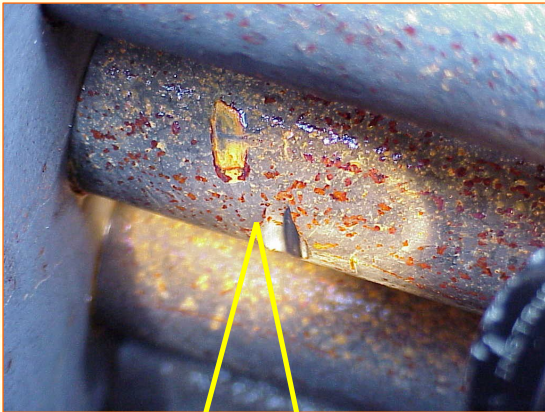
60% depth defect.  
This tube is 2nd row  
down in bundle tube  
matrix.
