Magnetec Monthly Chronicle

Issue No.7

WOW Only 4 Months of Service!

Subject: Organic acids/salts corrosion in Atmospheric Crude unit

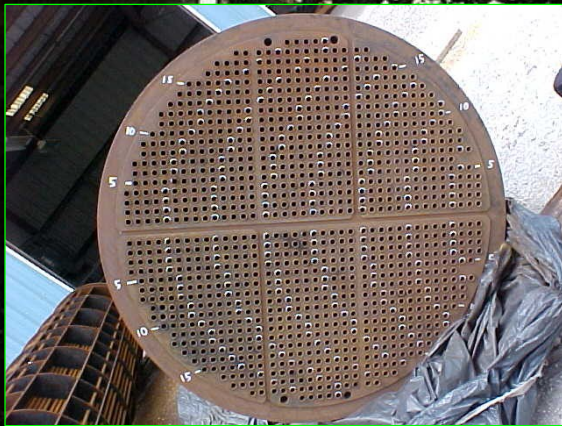
The exchanger is found in a large Gulf coast refinery. The bundle was recently replaced and preliminary visual inspection noted the bundle in good condition and was held for a possible spare bundle.

Area of most severe corrosion

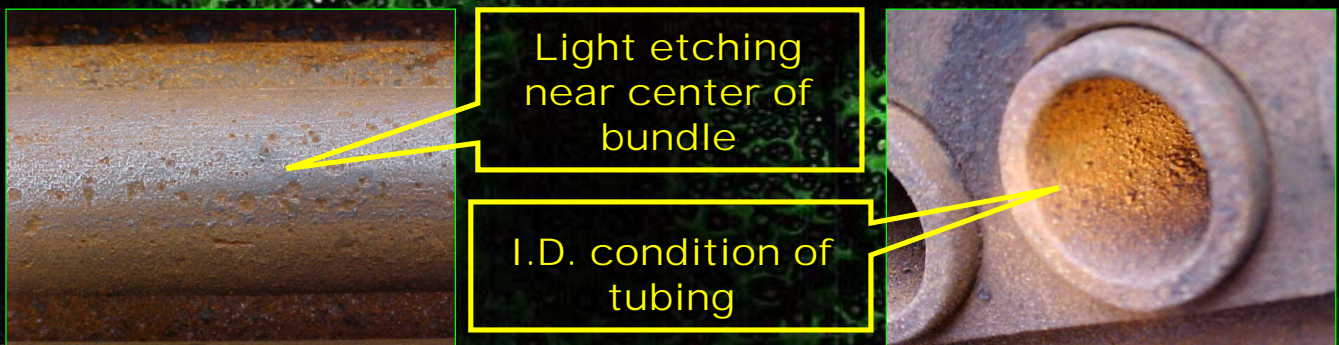
front of the bundle. It is the first 1/3 of the process gas path that the most lay-out of corrosion constituents occurs and the associated heavy corrosion is noted. The corrosion tends to taper and diminish in attack as the process gas works from the back of the bundle to the front outlet.

The past history for this exchanger service has many in-service failures and replacement bundles with service cycles as low as 4-months when 1st tube failure was noted. The history and past Eddy Current inspection has documented the active corrosion mechanism and location which could be controlled by a material upgrade resistant to the corrosion constituents within the process gas. Due to relative young age of the bundle and the severe O.D. corrosion detected the bundle is considered in poor service condition and was retubed with a material upgrade.
