Magnetec Monthly Chronicle

Issue No.7

WOW Only 4 Months of Service!

Subject: Organic acids/salts corrosion in Atmospheric Crude unit.

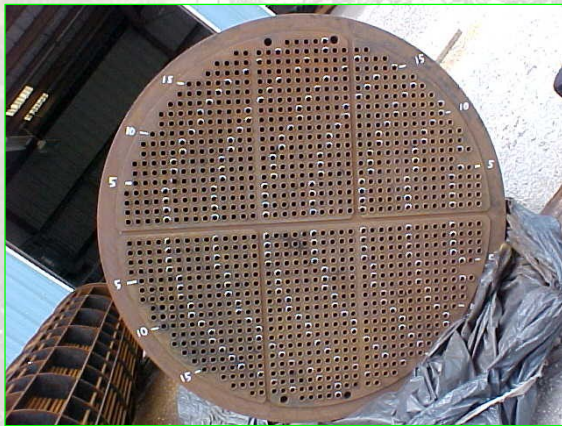
Area of most
severe
corrosion

tubing across the entire bundle matrix with the bundle being previously hydro-blasted and located on the bundle pad. The Eddy Current Test detected severe corrosion wastage and pitting in heavy concentrations at the last 1/3 of the bundle length near the u-bends which corresponds to the shell side inlet. The I.D. surface of the tubing was found with no active corrosion or wall loss greater than 10%. The severe O.D. general corrosion extending from the 13th baffle to the u-bends where the most severe attack has occurred.

The past history for this exchanger service has many in-service failures and replacement bundles with service cycles as low as 4 months when 1st tube failure was noted. The history and past Eddy Current inspection has documented the active corrosion mechanism and location which could be controlled by a material upgrade resistant to the corrosion constituents within the process gas. Due to relative young age of the bundle and the severe O.D. corrosion detected the bundle is considered in poor service condition and was retubed with a material upgrade.
