Monthly Chronicle

Issue No.17

Feb 2007

Subject: Creep

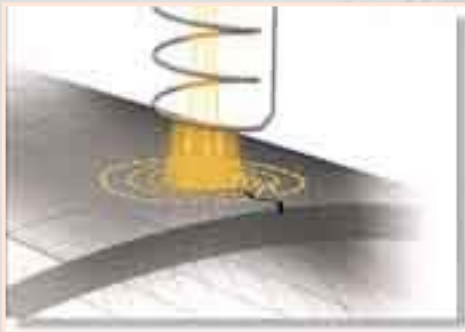
The principle of the eddy current method is that a determined energy flux is induced into the material to be tested with an EC-probe by generating a magnetic field which penetrates the material causing eddy currents. Any defects or irregularities in the grain structure disturb the energy flow leading to indications which correlate to the specific changes in material.

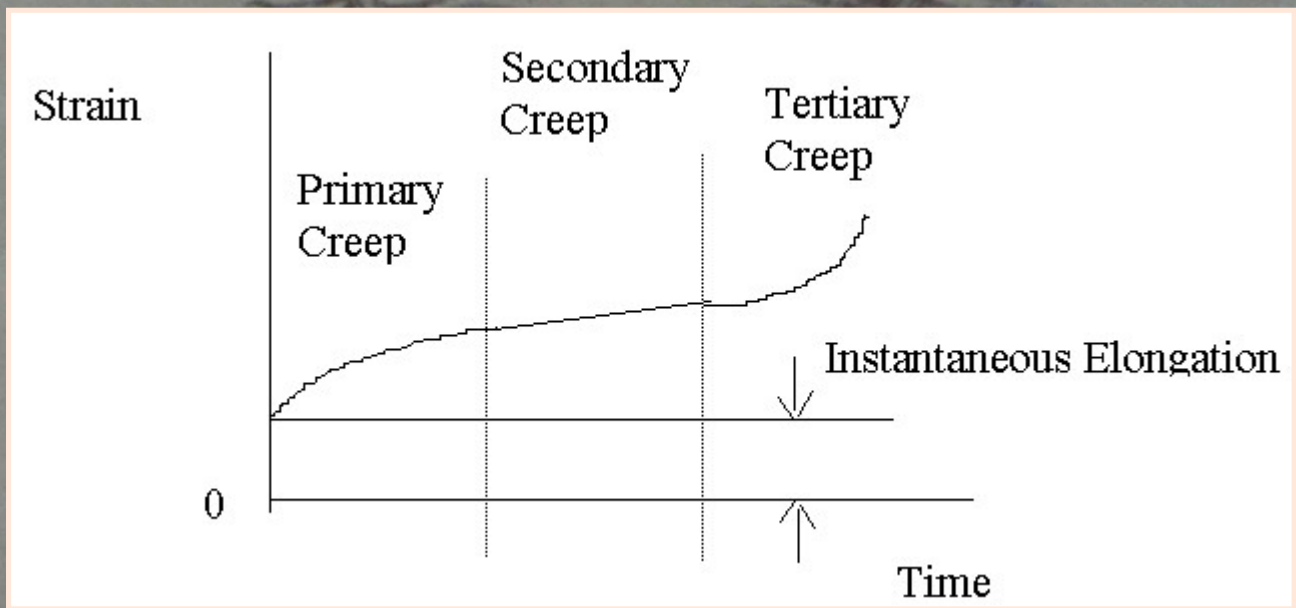
Figure #2

Reformer tubes undergo creep strain, in the form of diametrical growth, from the first day that they are fired.

The ability to accurately measure and record this growth means that the tubes' condition can be monitored from day one. Therefore, not only can individual tubes be retired from service at an appropriate time, but also the reformer as a whole can be assessed for performance. The use of Eddy Current inspection techniques is not only useful in preventing tube failures but has huge potential in optimizing production from the whole tube set without sacrificing reliability. Of course, external diameter measurements can be used but they are limited as the automated devices only measure across one diameter and are often access restricted by tube bowing.
